Geotechnical and Construction Materials Testing Services

January 27, 2010

Re: Report of Subsurface Investigation
Leggett Park Sanitary Sewer Improvements
Rocky Mount, North Carolina
GeoTechnologies Project No. 1-10-0029-EA

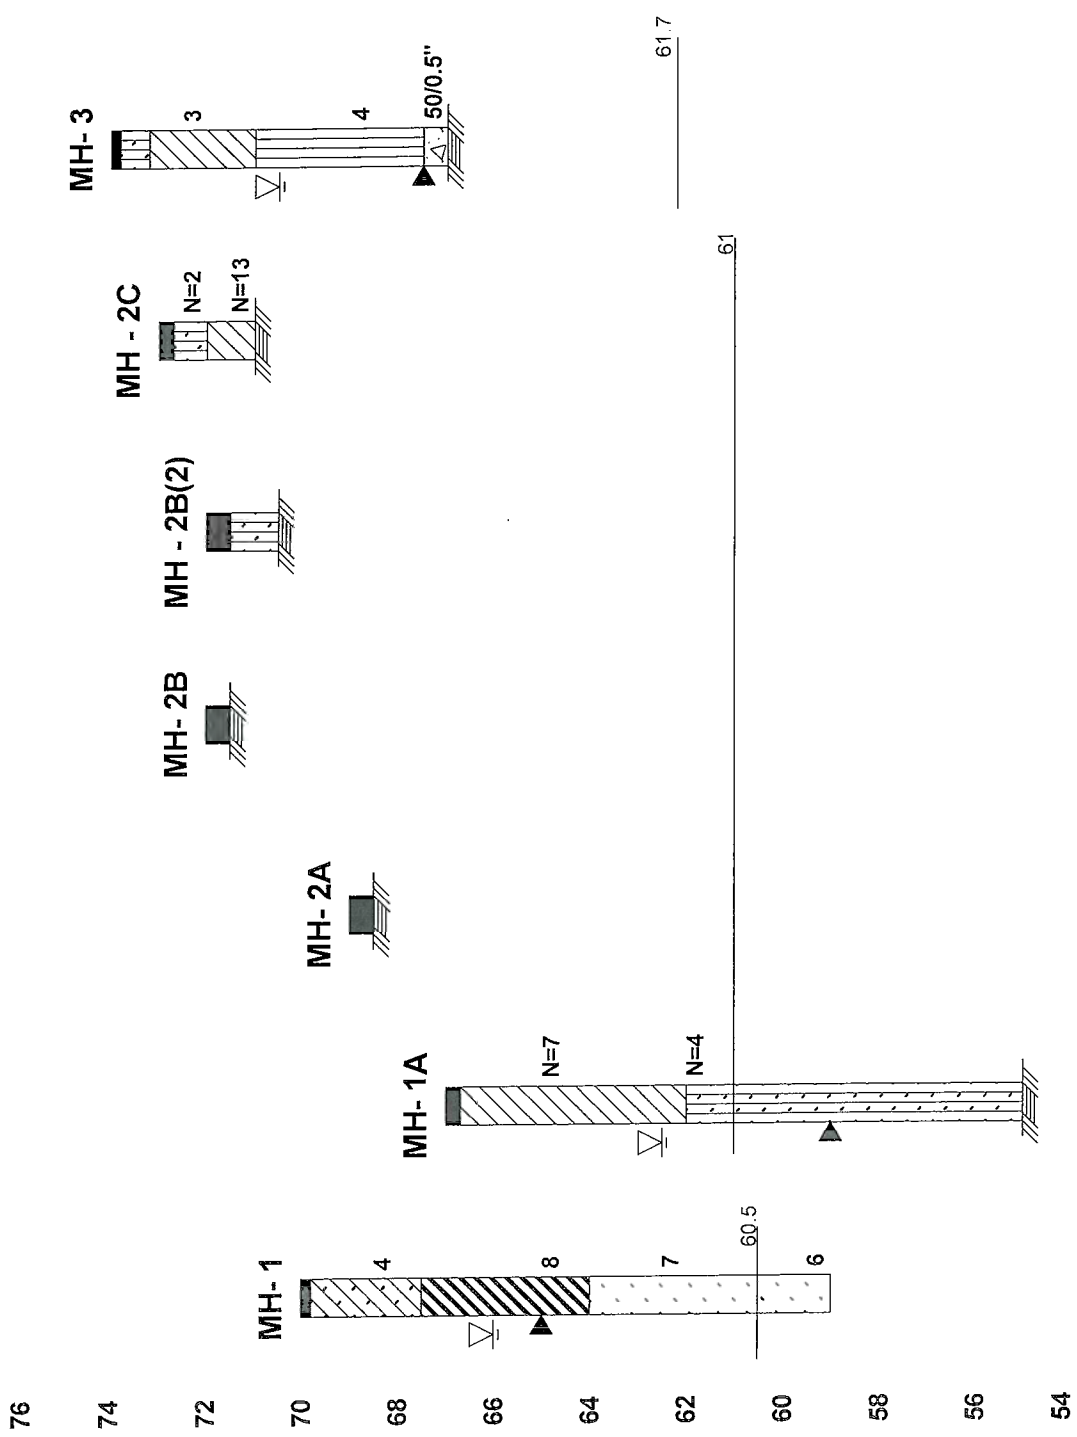
FIGURE No:1A

Generalized subsurface profiles prepared from the investigation data are attached to this report as Figures 1A-1E to graphically illustrate subsurface conditions encountered at this site. More detailed descriptions of the conditions encountered at the individual locations investigated are then presented on the attached boring records.

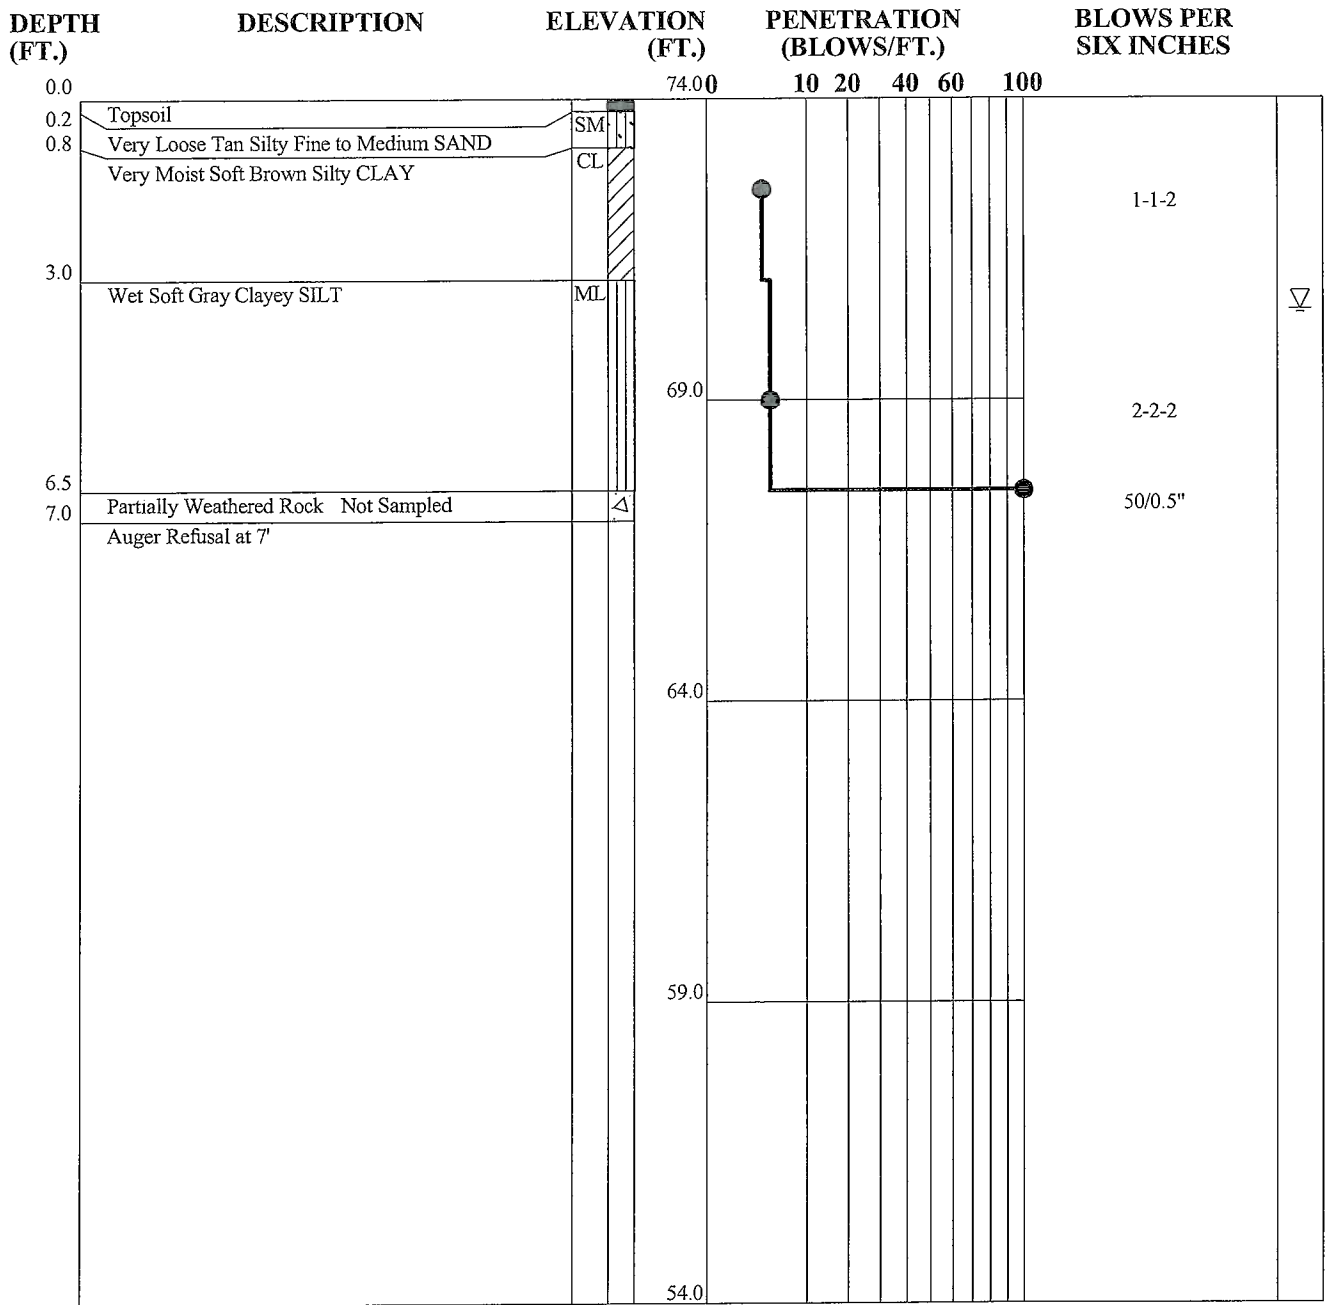
JOB NUMBER 1 10-0029-EA
BORING NUMBER MH- 3
DATE 1-25-10

Groundwater encountered at 3.5' and caved at 6.5' at time of boring.

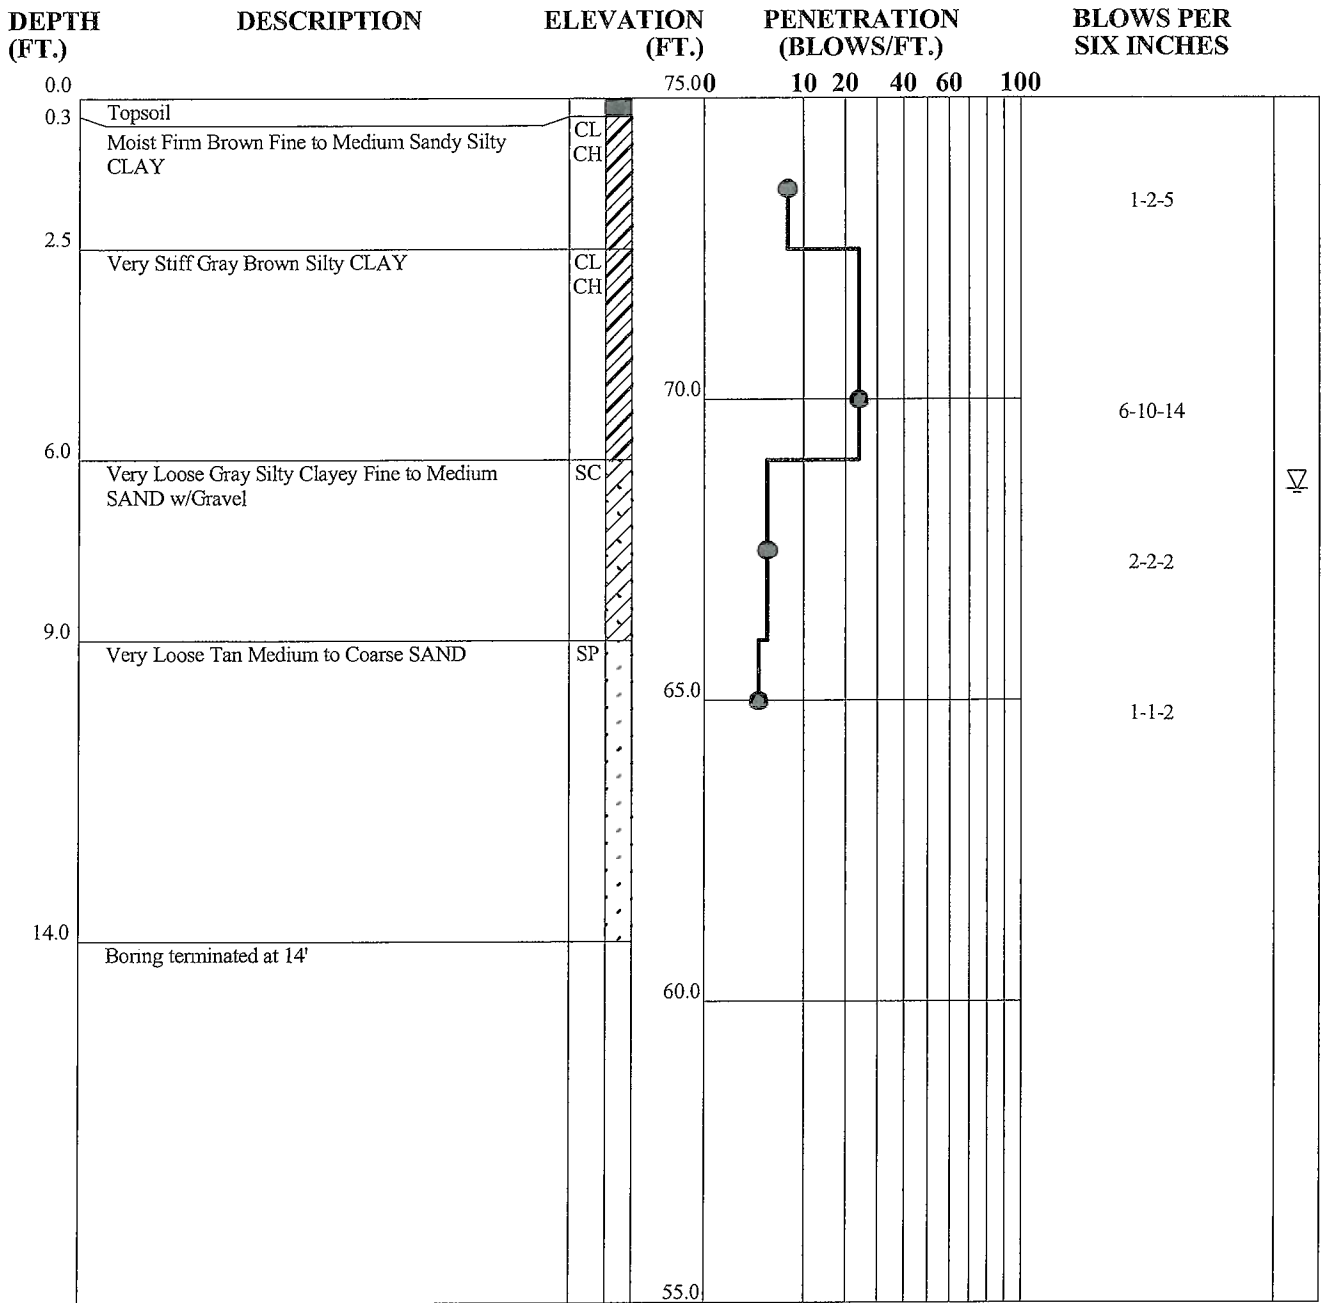
JOB NUMBER 1-10-0029-EA
BORING NUMBER MH- 4
DATE 1-25-10

Groundwater encountered at 6.5' and caved at 8' at time of boring.

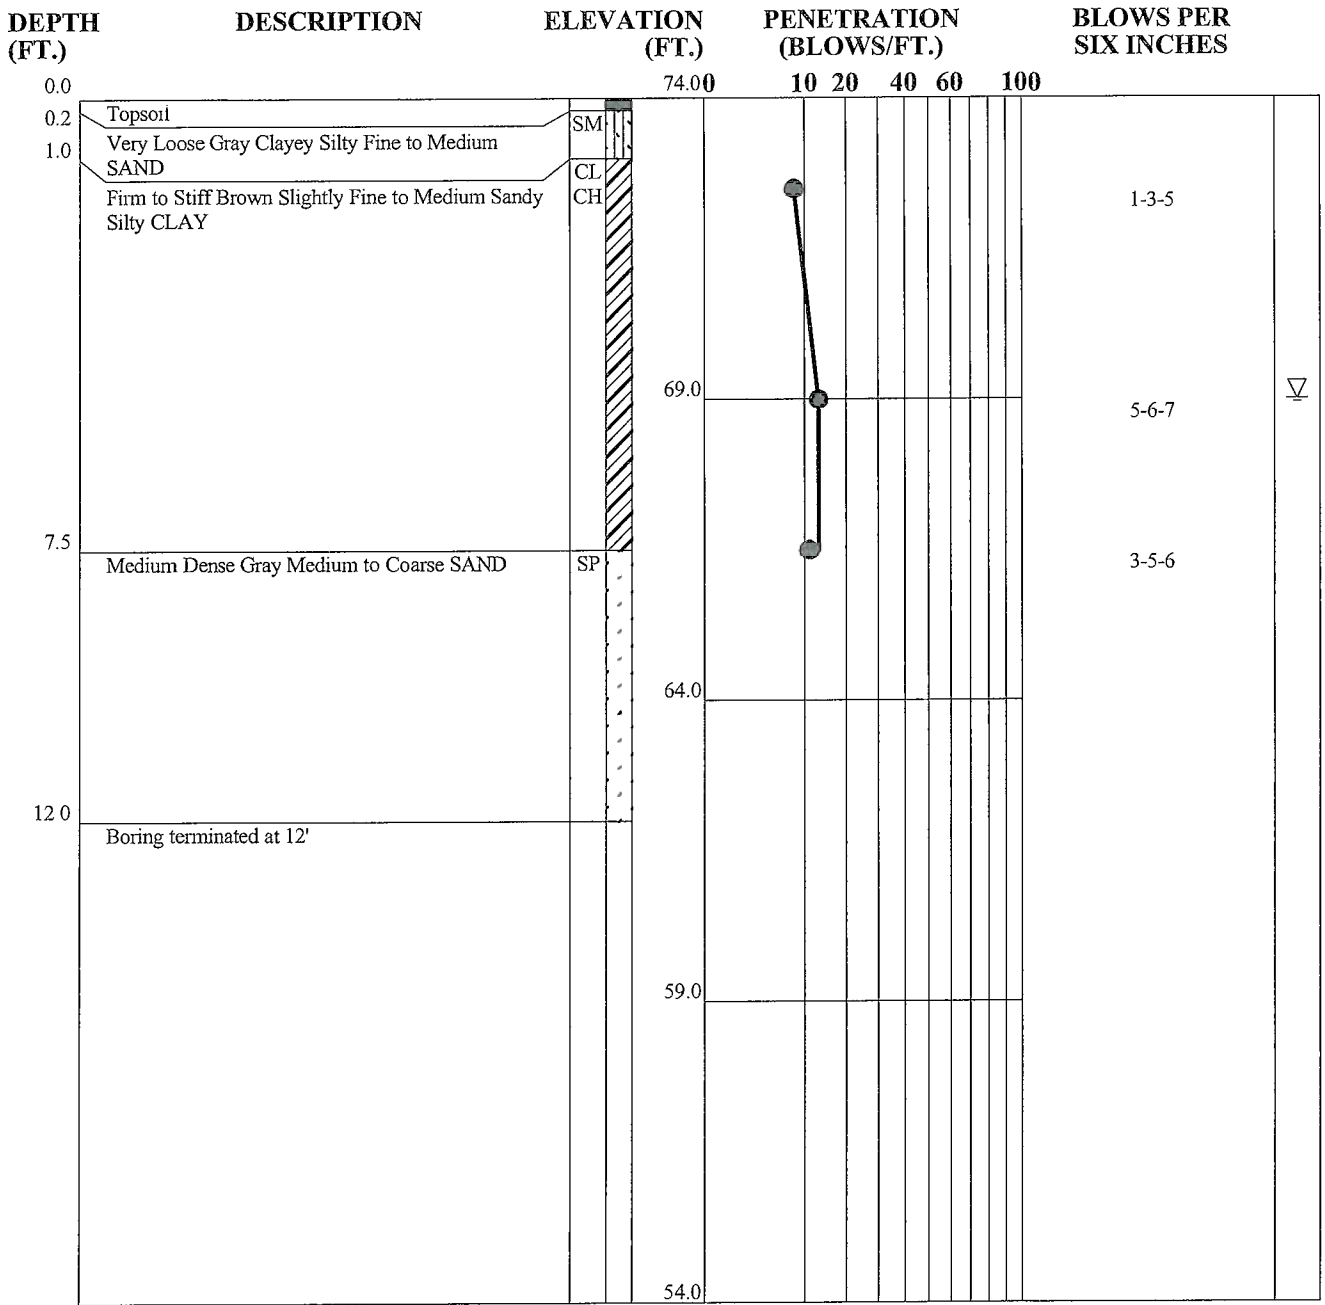
JOB NUMBER 1-10-0029-EA
BORING NUMBER MH- 5
DATE 1-25-10

Groundwater encountered at 5' and caved at 6.0' at time of boring.

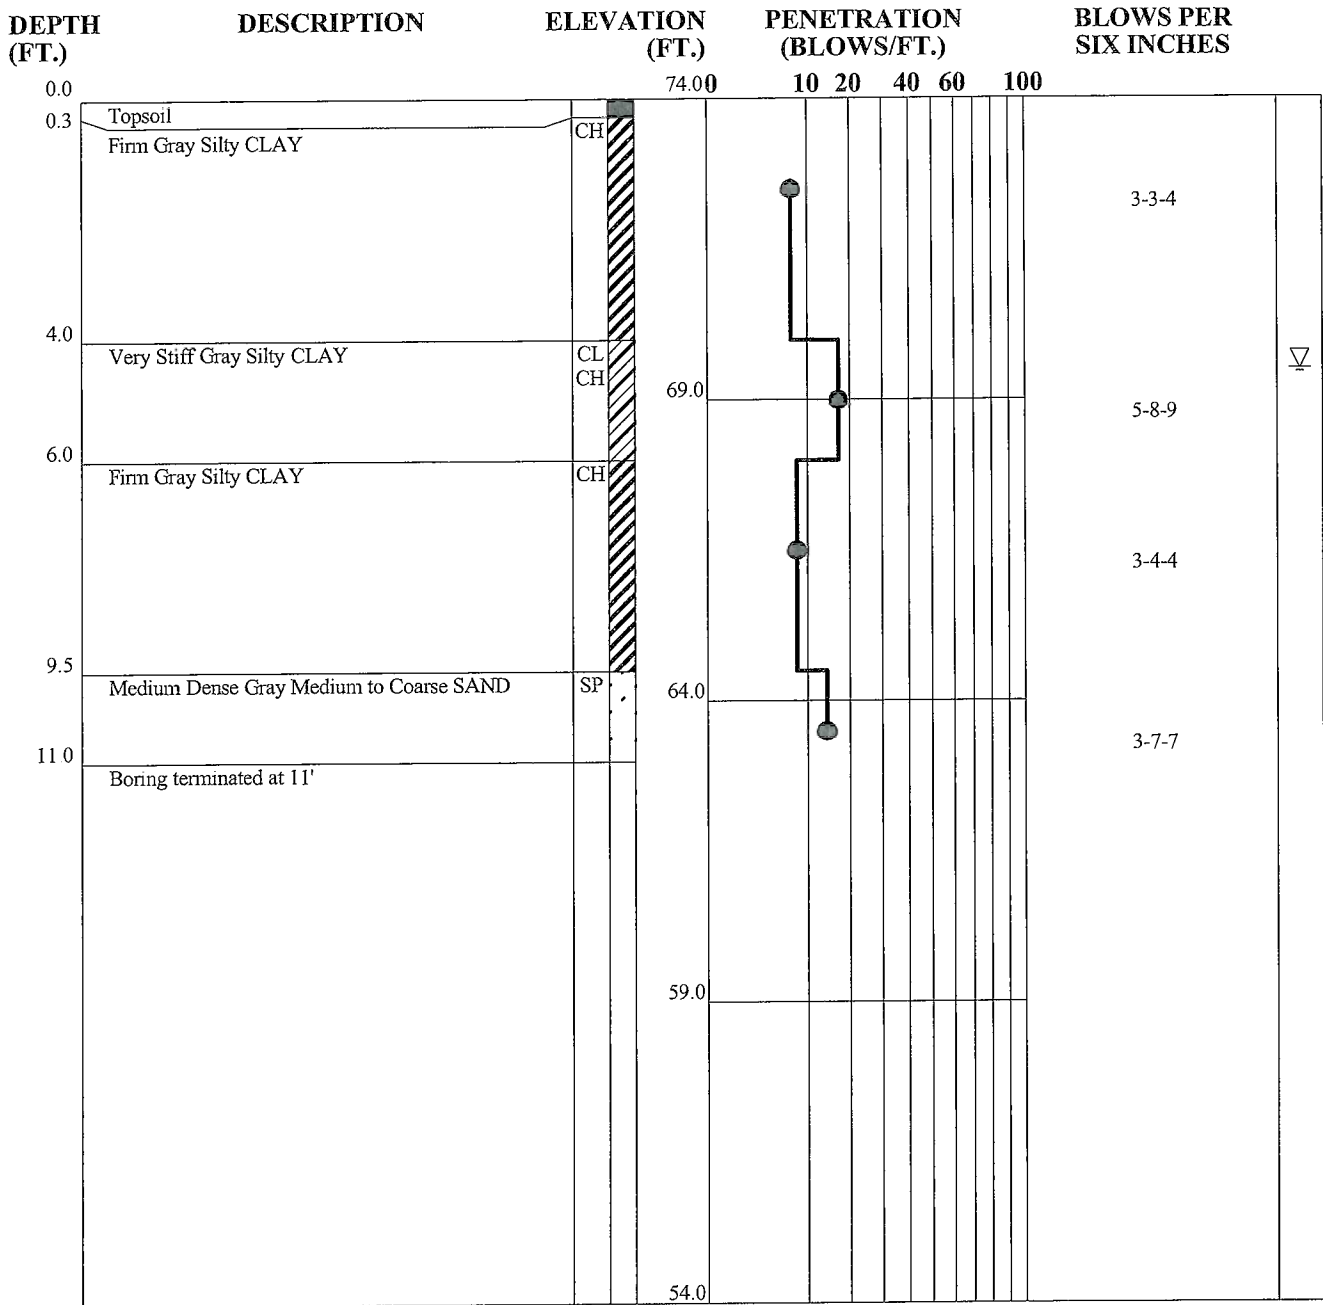
JOB NUMBER 1-10-0029-EA
BORING NUMBER MH-7
DATE 1-25-10

Groundwater encountered at 4.5' and caved at 7.5' at time of boring.

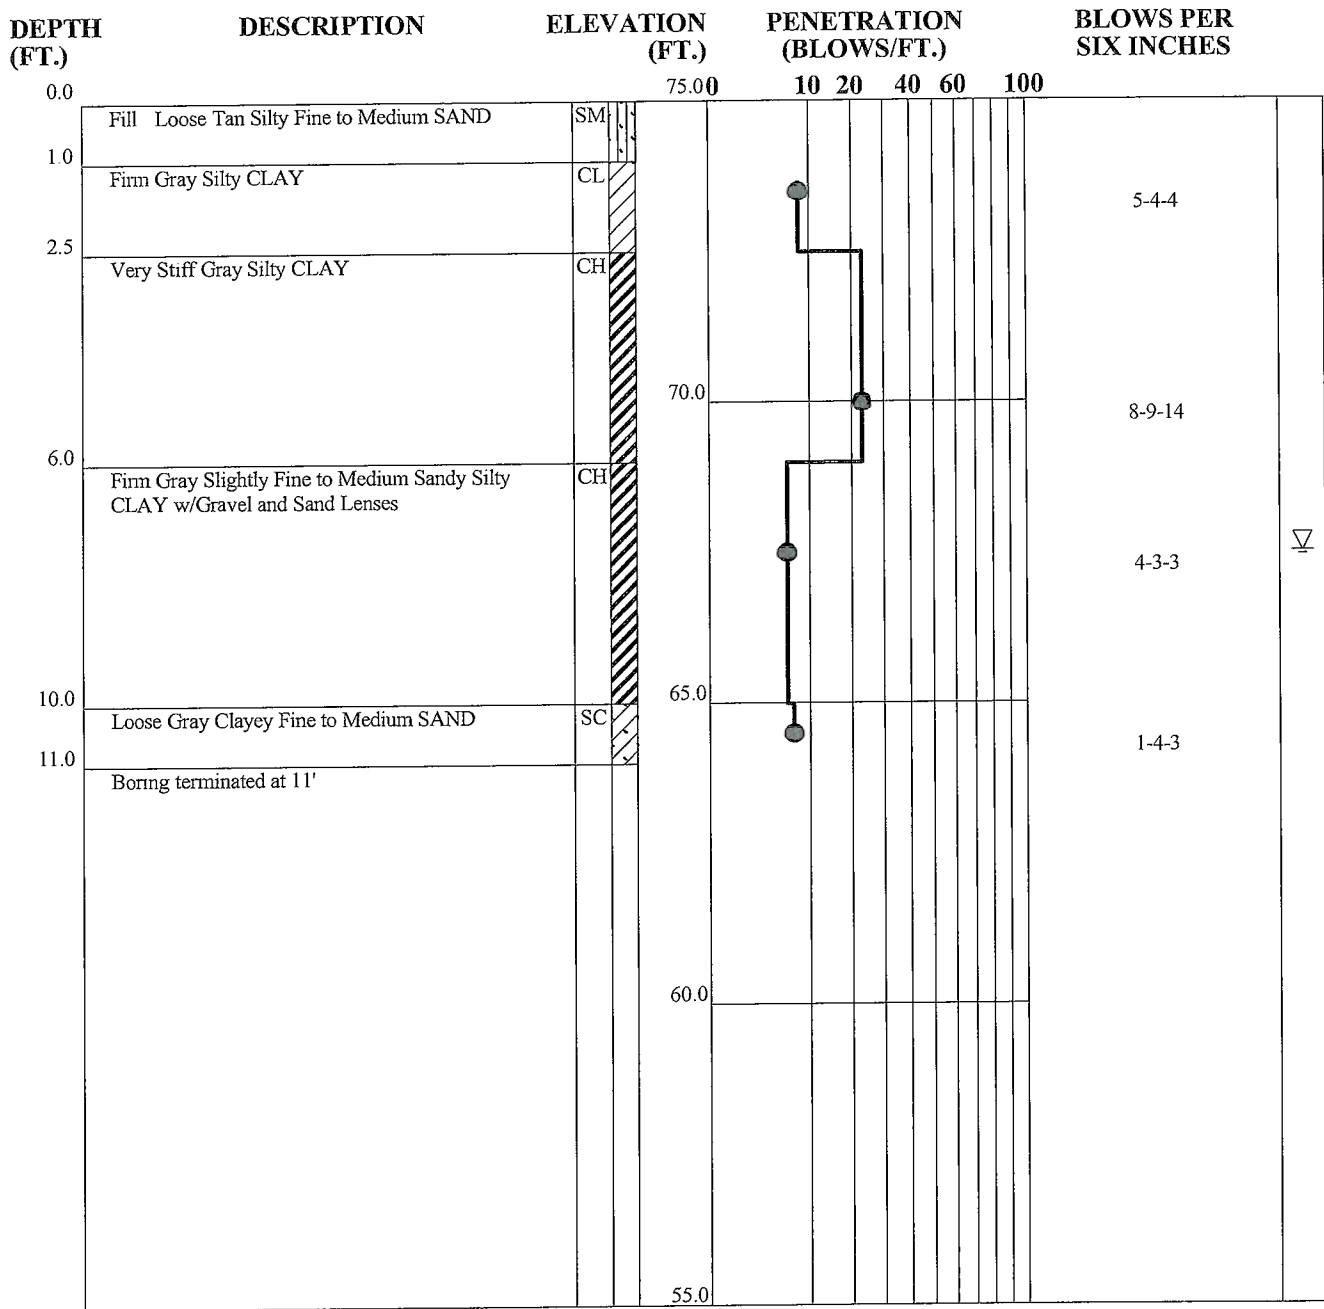
JOB NUMBER 1-10-0029-EA
BORING NUMBER MH- 9
DATE 1-25-10

Groundwater encountered at 7.5' and caved at 7.5' at time of boring.

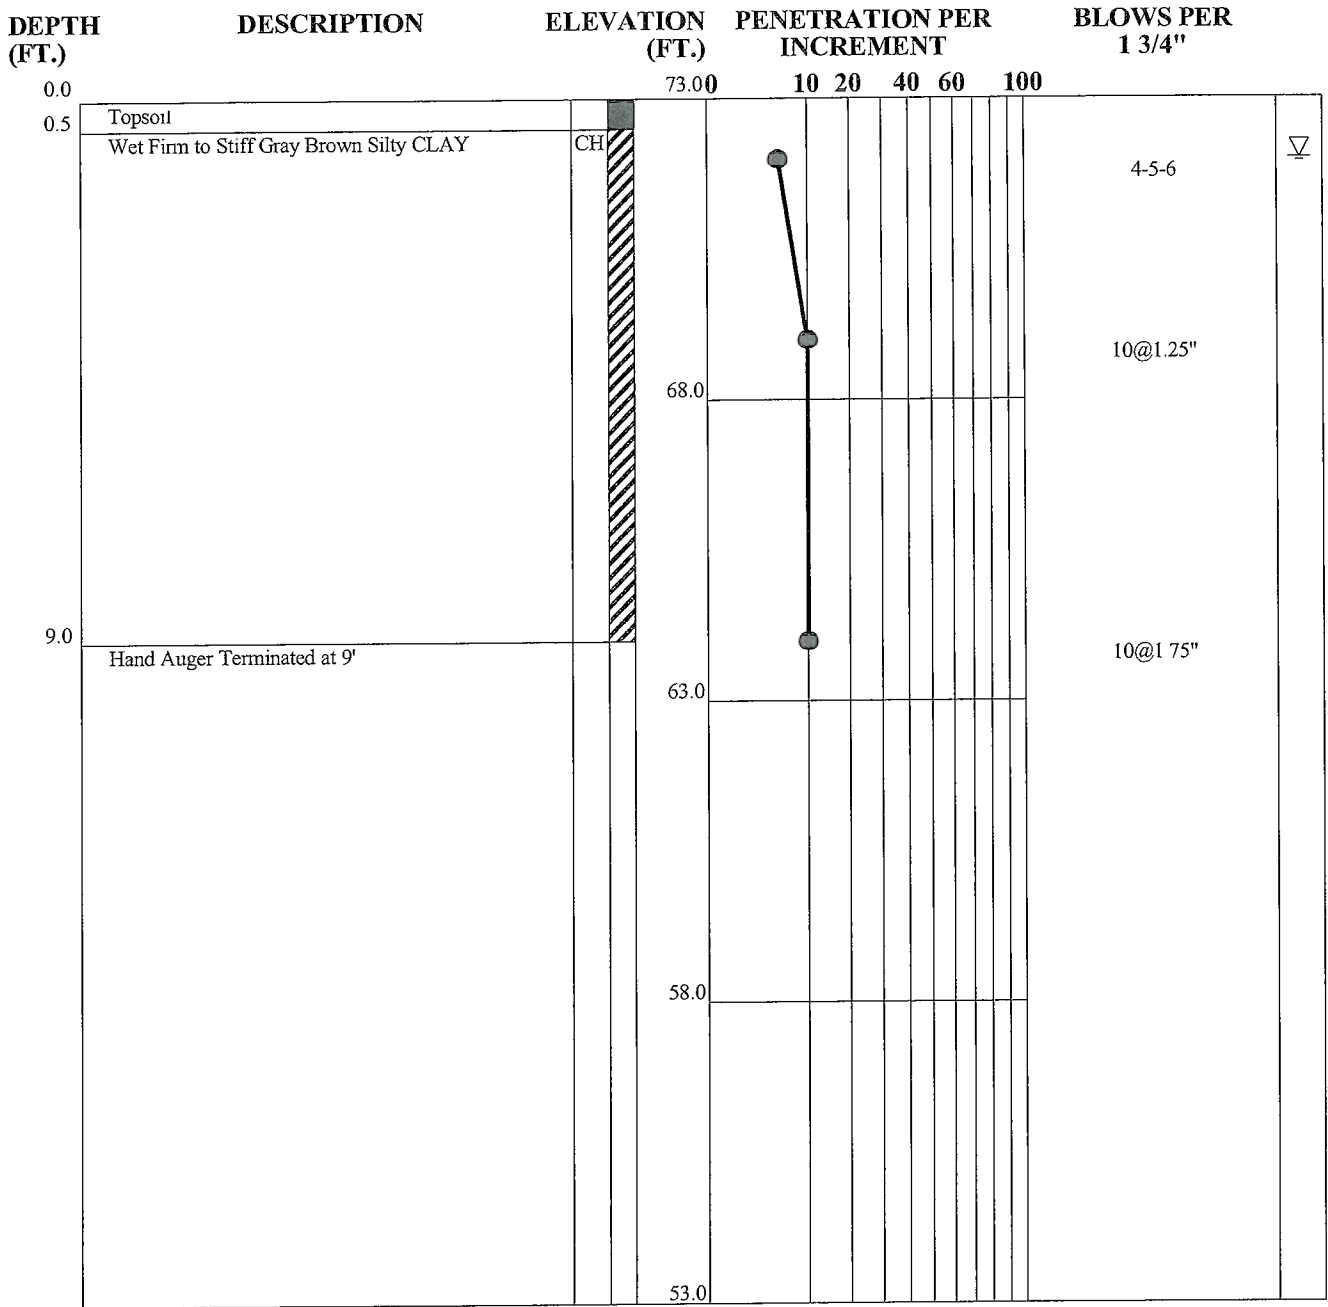
JOB NUMBER 1-10-0029-EA
BORING NUMBER MH-10
DATE 1-25-10

Groundwater encountered at 1' at time of boring.

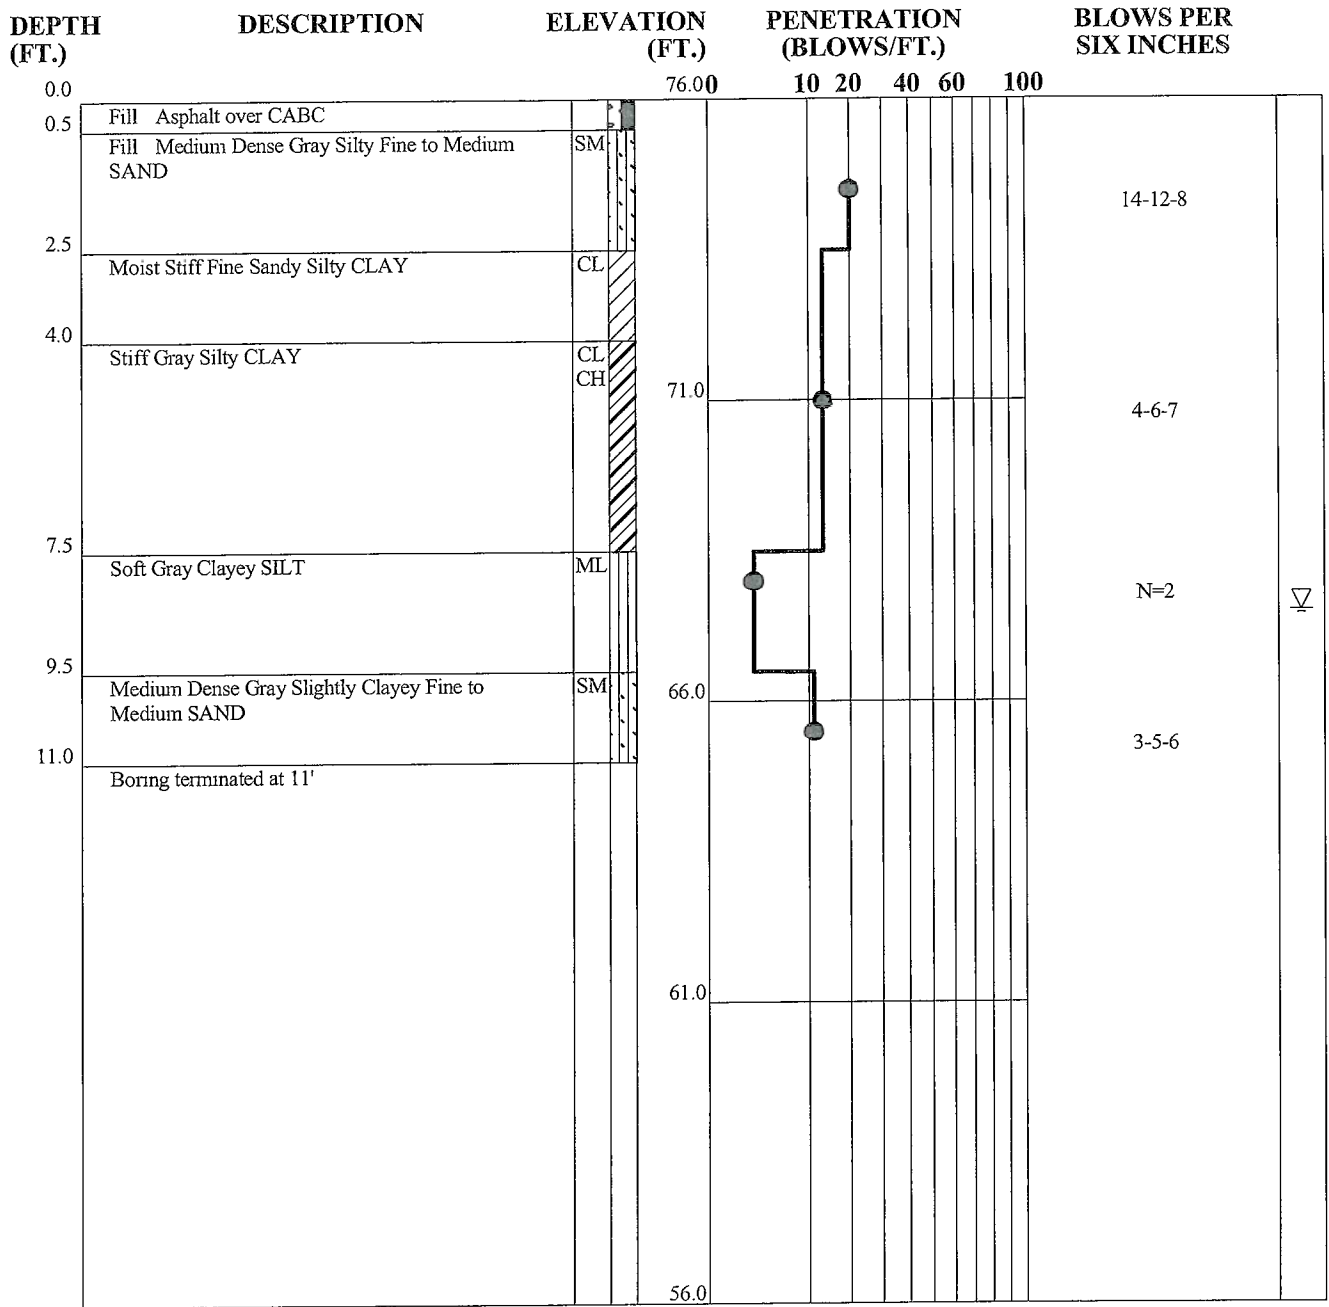
JOB NUMBER 1-10-0029-EA
BORING NUMBER MH-12
DATE 1-25-10

Groundwater encountered at 8.5' and caved at 8' at time of boring.

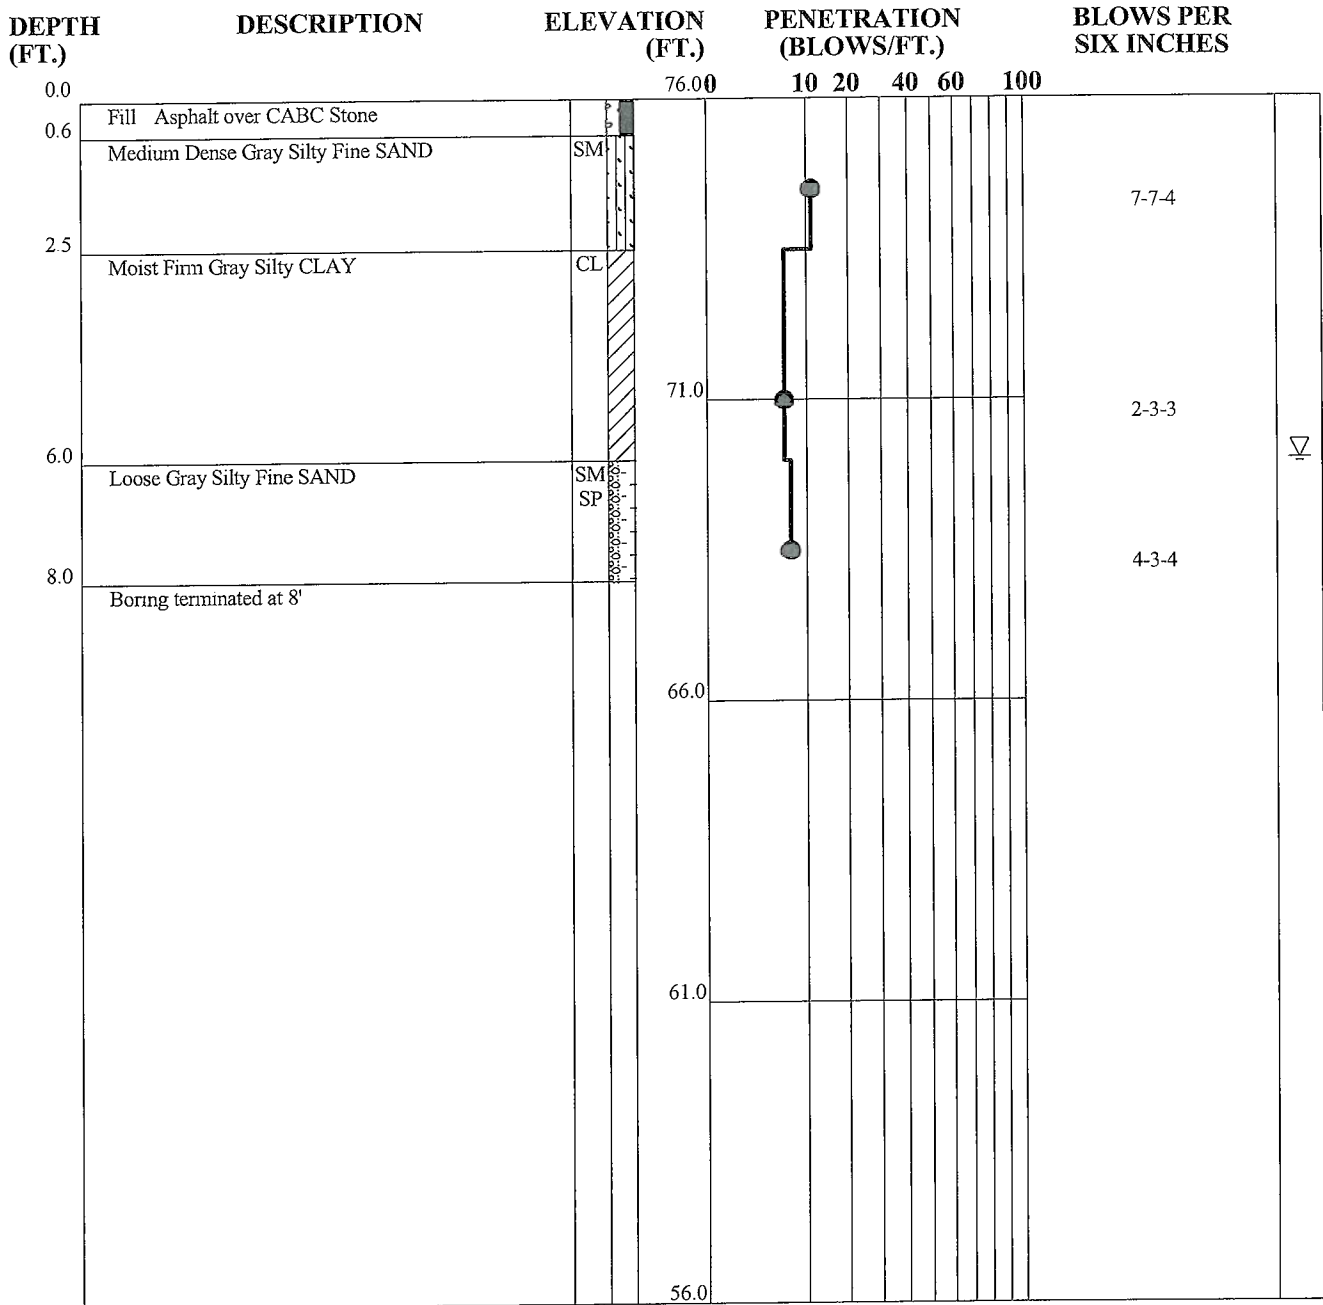
JOB NUMBER 1-10-0029-EA
BORING NUMBER MH-14
DATE 1-25-10

Groundwater encountered at 6' and caved at 5.5' at time of boring.

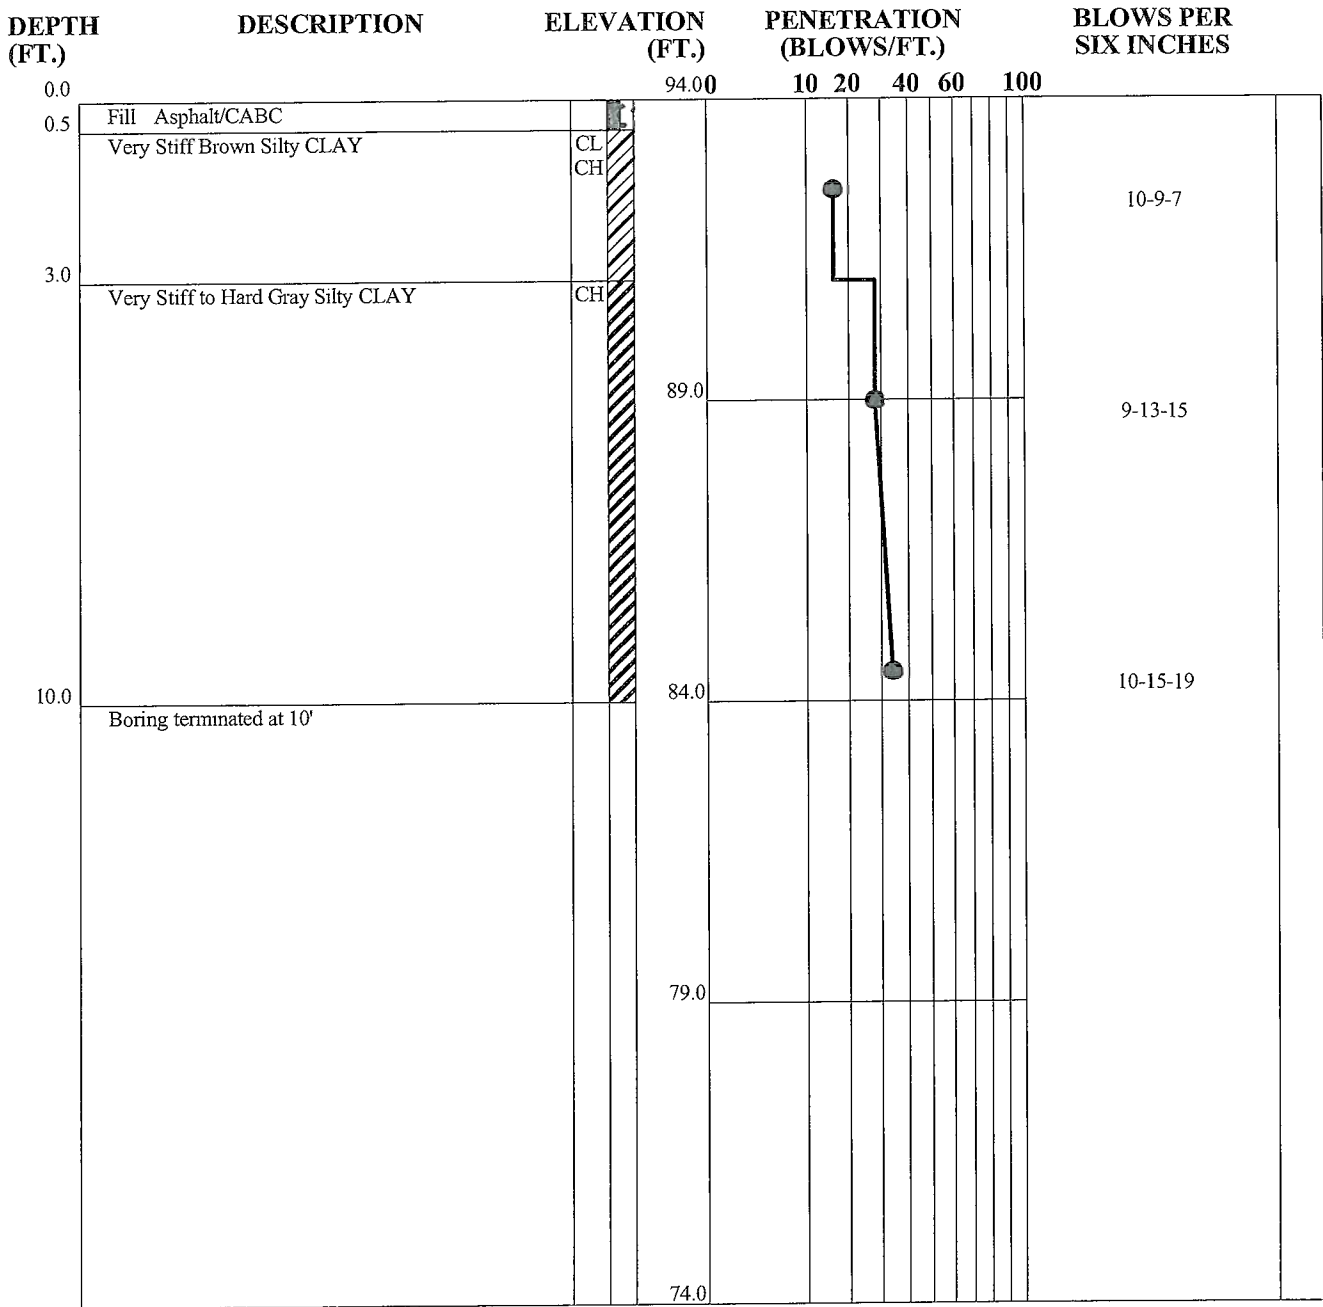
JOB NUMBER 1-10-0029-EA
BORING NUMBER MH-16
DATE 1-25-10

Dry at time of boring.

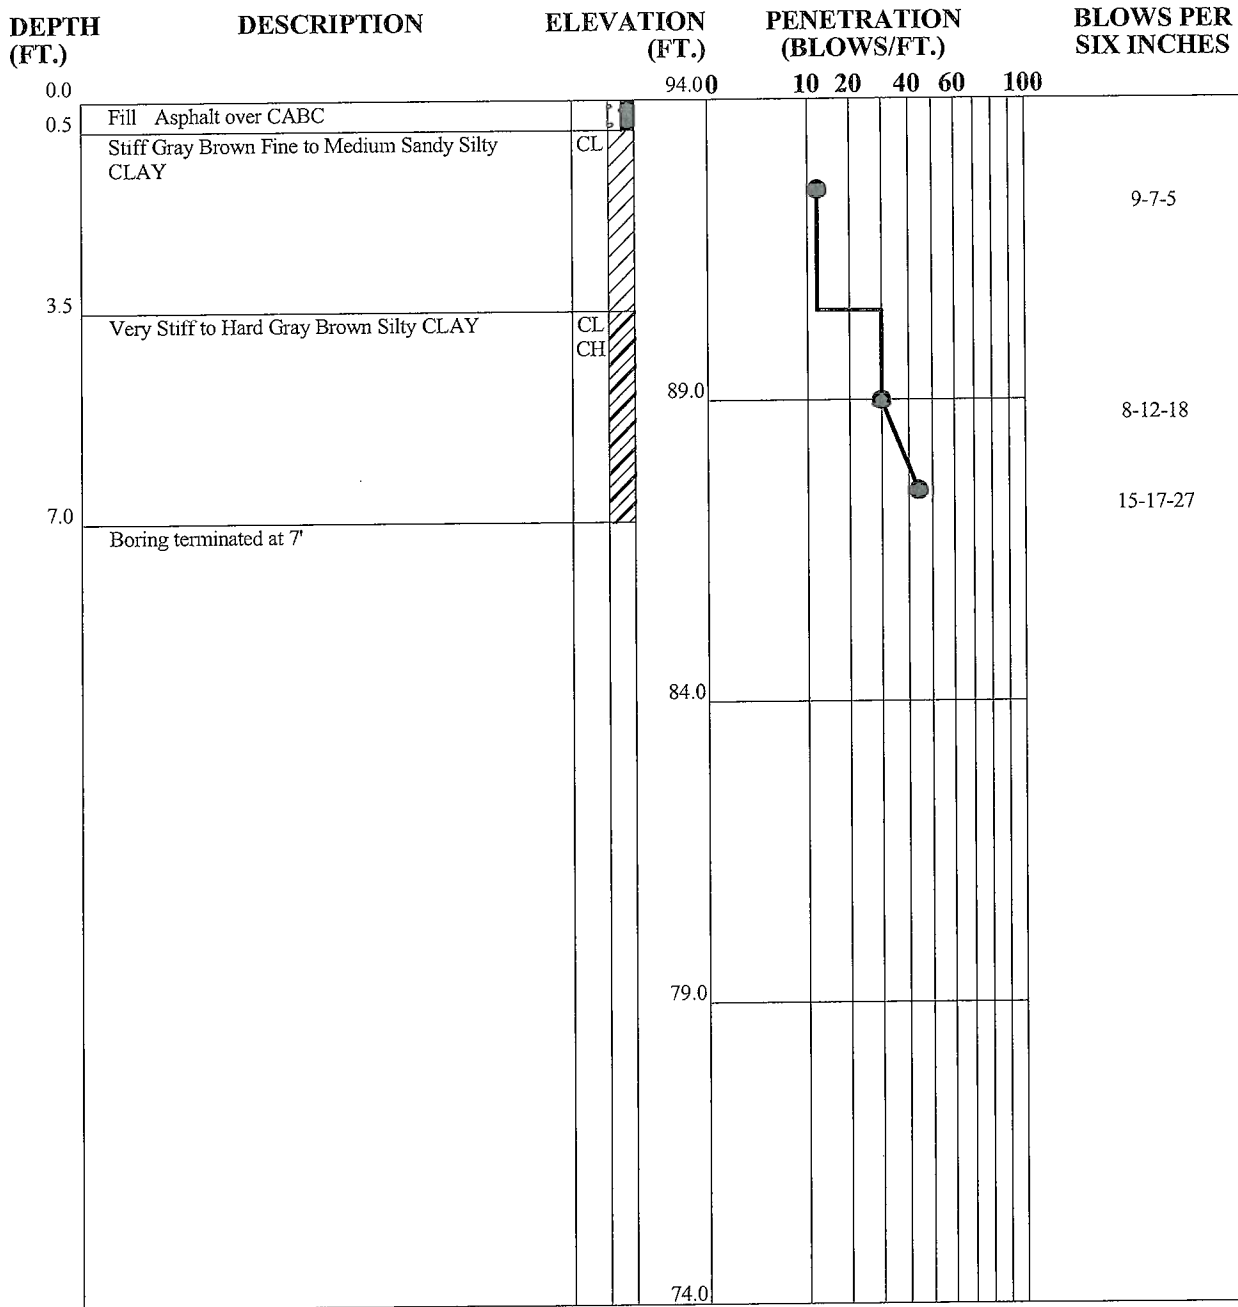
JOB NUMBER 1-10-0029-EA
BORING NUMBER MH-17
DATE 1-25-10

Dry at time of boring.

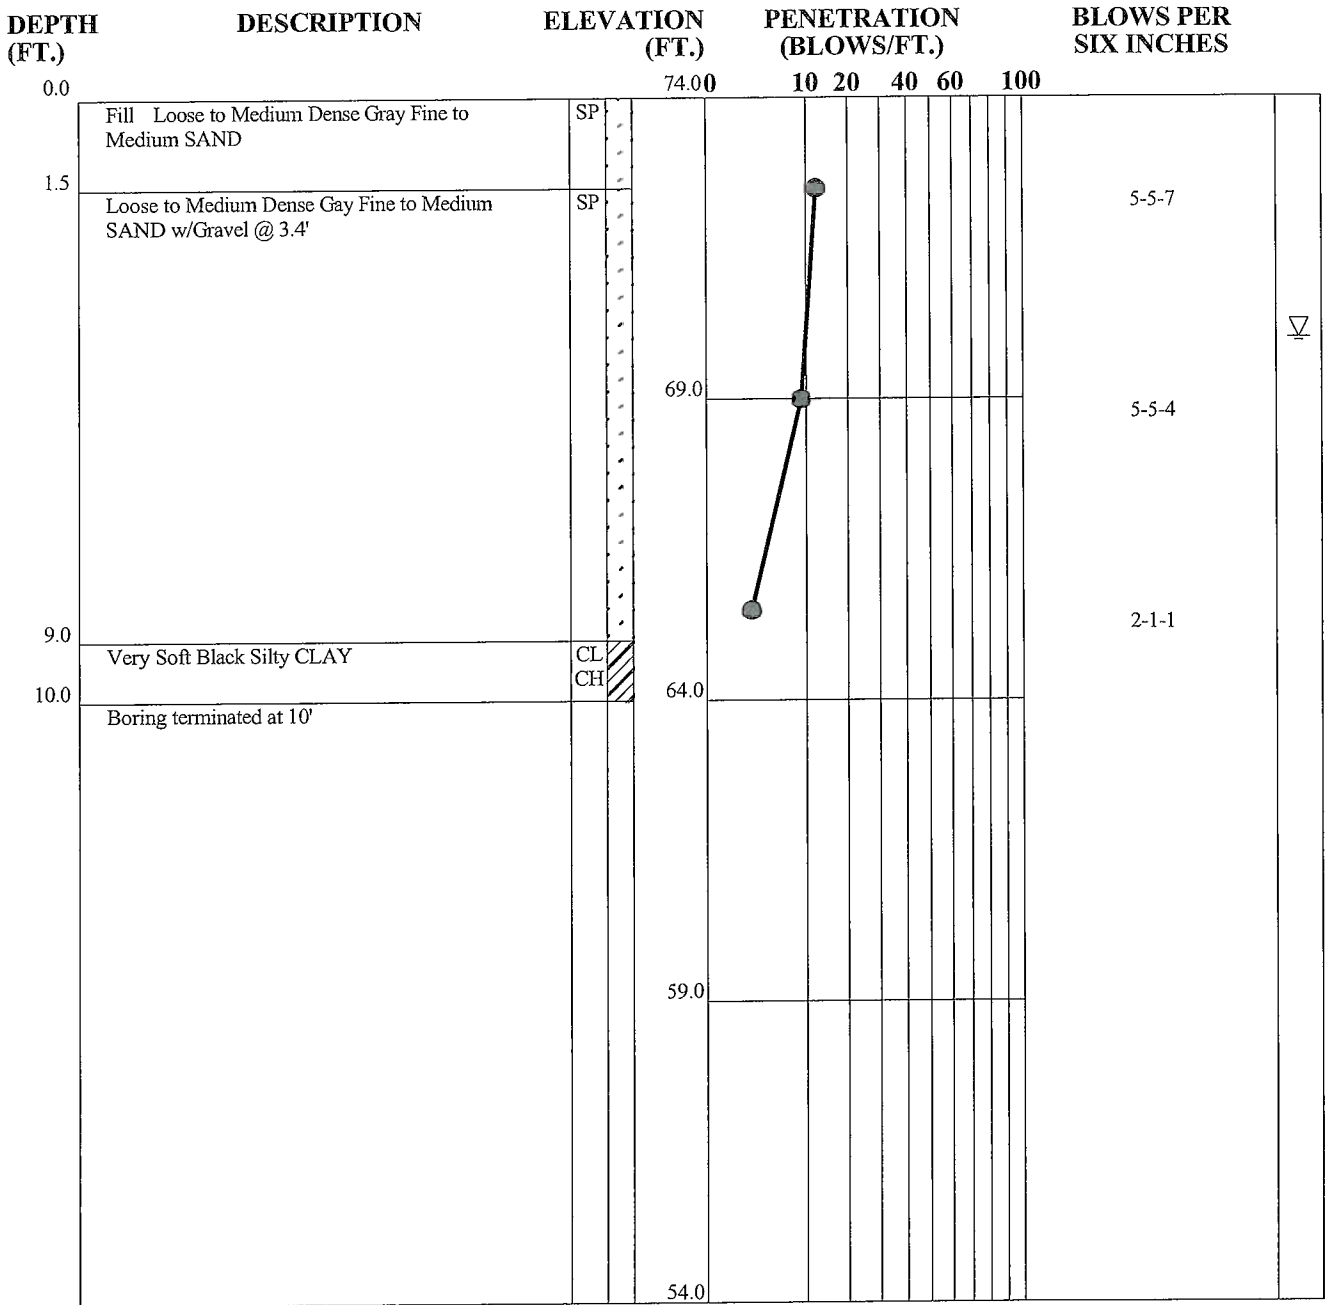
JOB NUMBER 1-10-0029-EA
BORING NUMBER MH-18
DATE 1-25-10

Groundwater encountered at 4' and caved at 4.5' at time of boring.

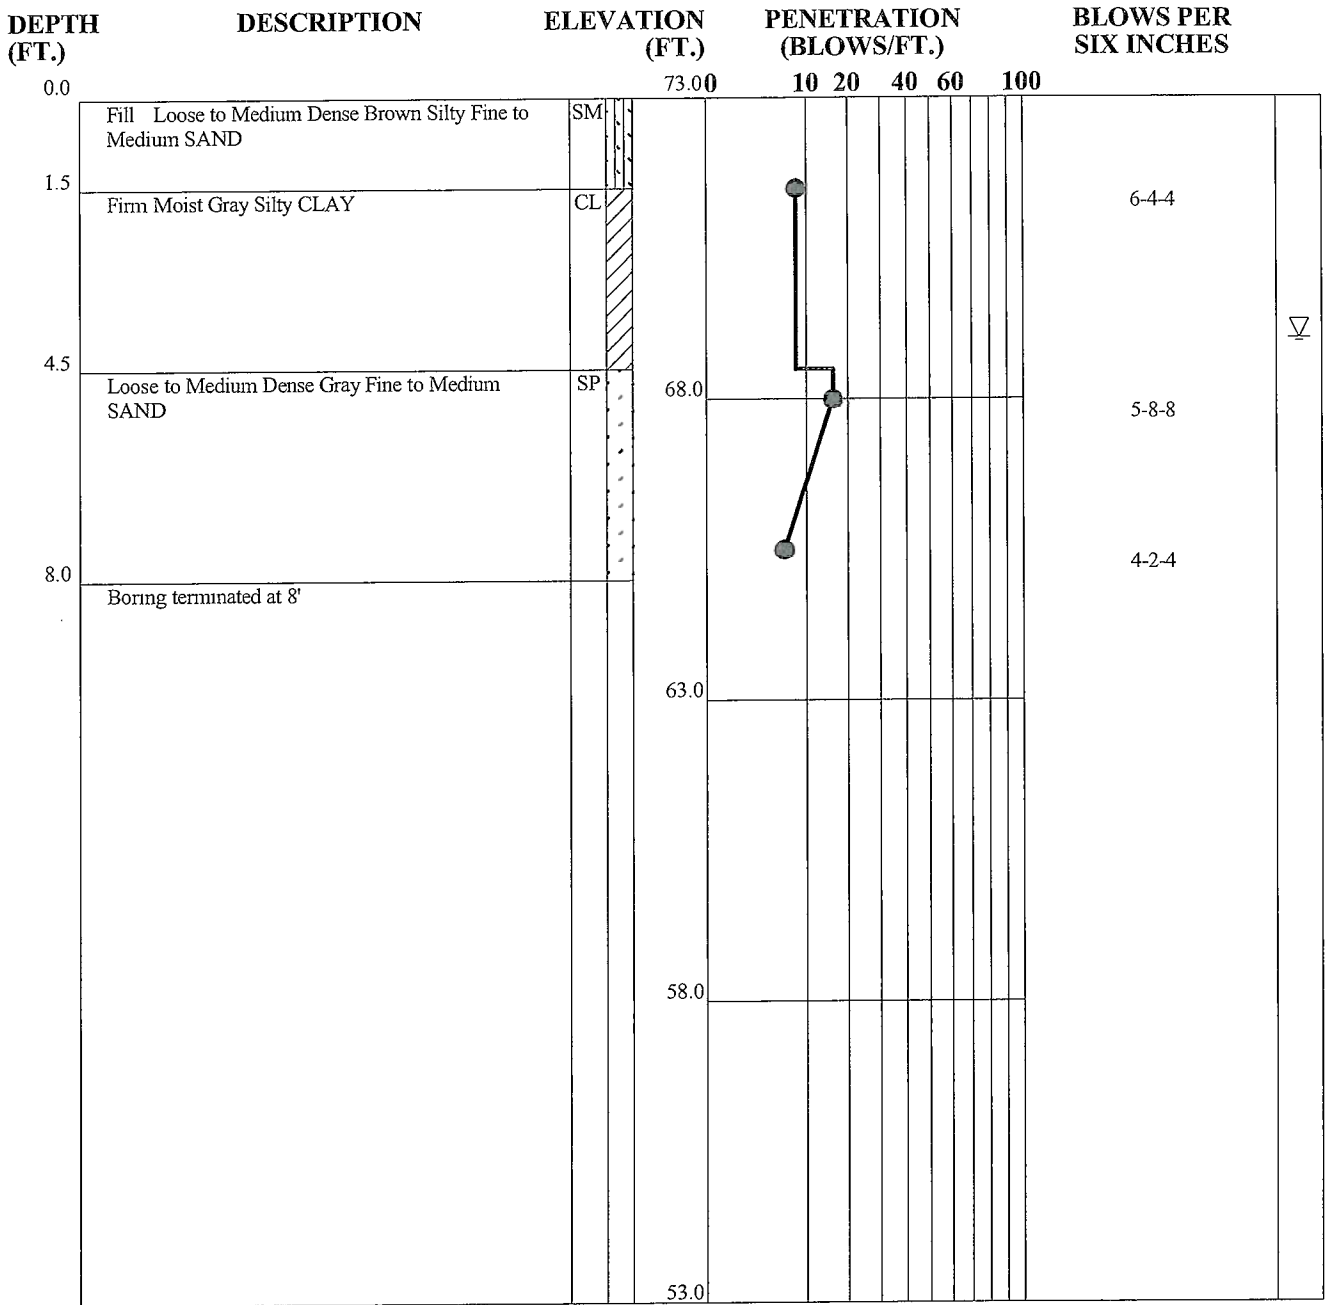
JOB NUMBER 1 10-0029-EA
BORING NUMBER MH-19
DATE 1-25-10

Groundwater encountered at 4' and caved at 5' at time of boring.
