Geotechnical and Construction Materials Testing Services

January 27, 2010

Re: Report of Subsurface Investigation
Leggett Park Sanitary Sewer Improvements
Rocky Mount, North Carolina
GeoTechnologies Project No. 1-10-0029-EA

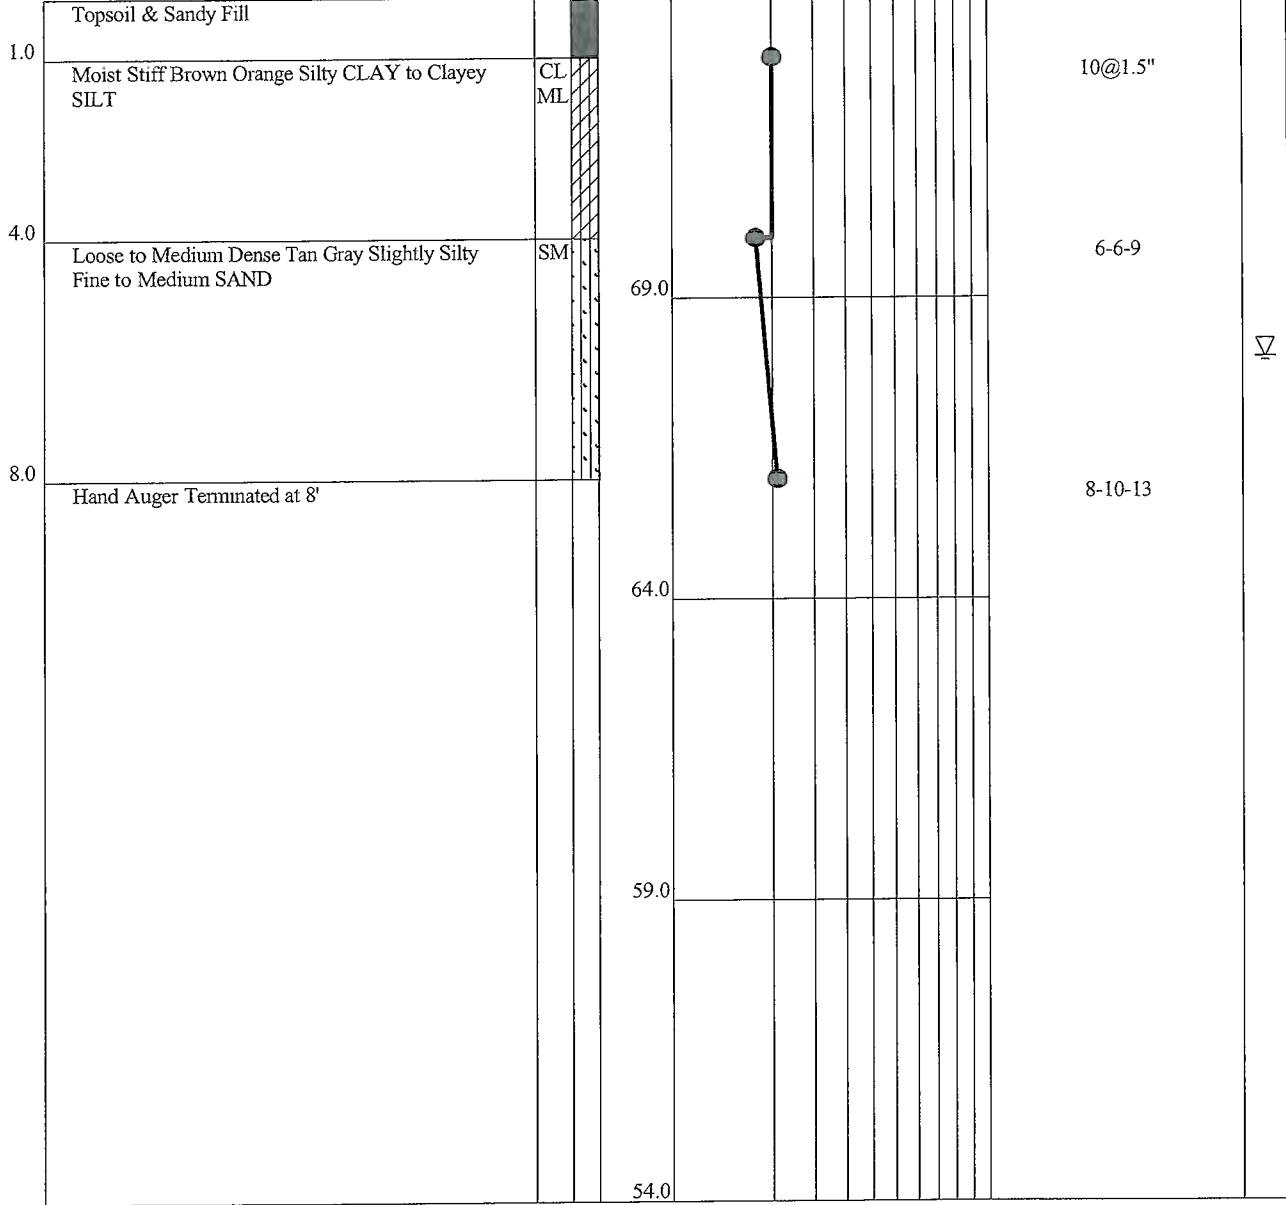
JOB NUMBER 1-10-0029-EA
BORING NUMBER MH-21
DATE 1-25-10

Groundwater encountered at 6' and caved at 7' at time of boring.

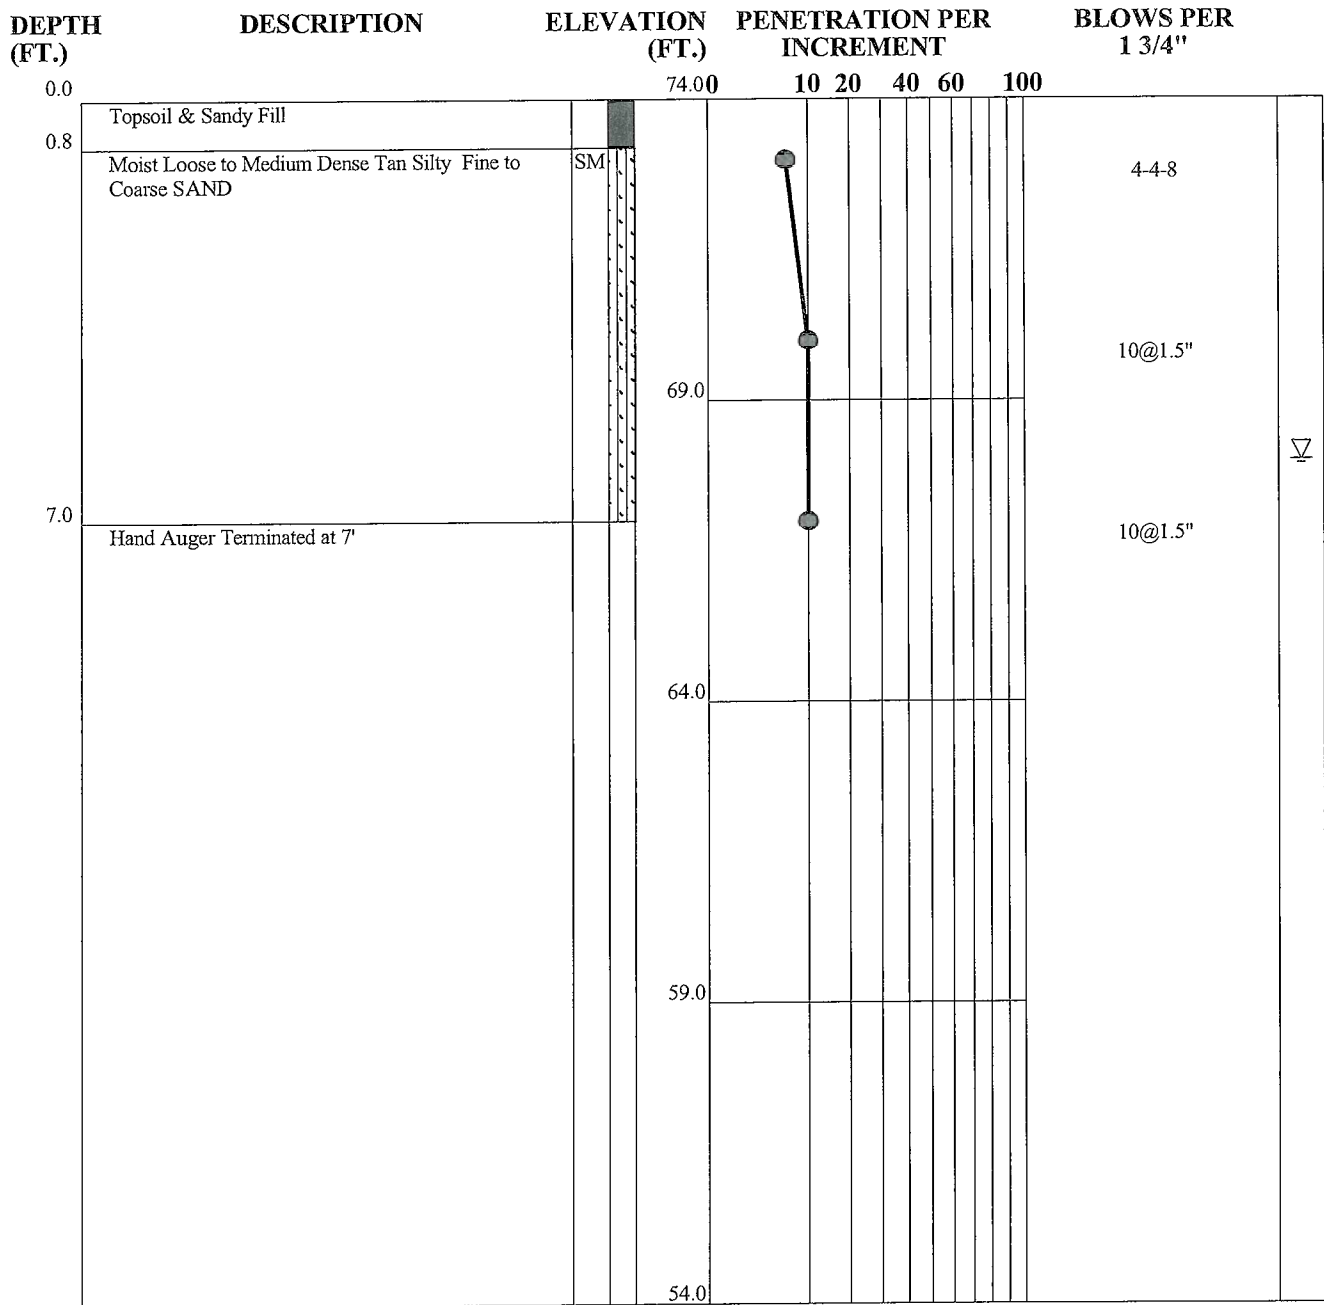
JOB NUMBER 1-10-0029-EA
 BORING NUMBER MH-23
 DATE 1-25-10

Groundwater encountered at 6' and caved at 6.5' at time of boring.

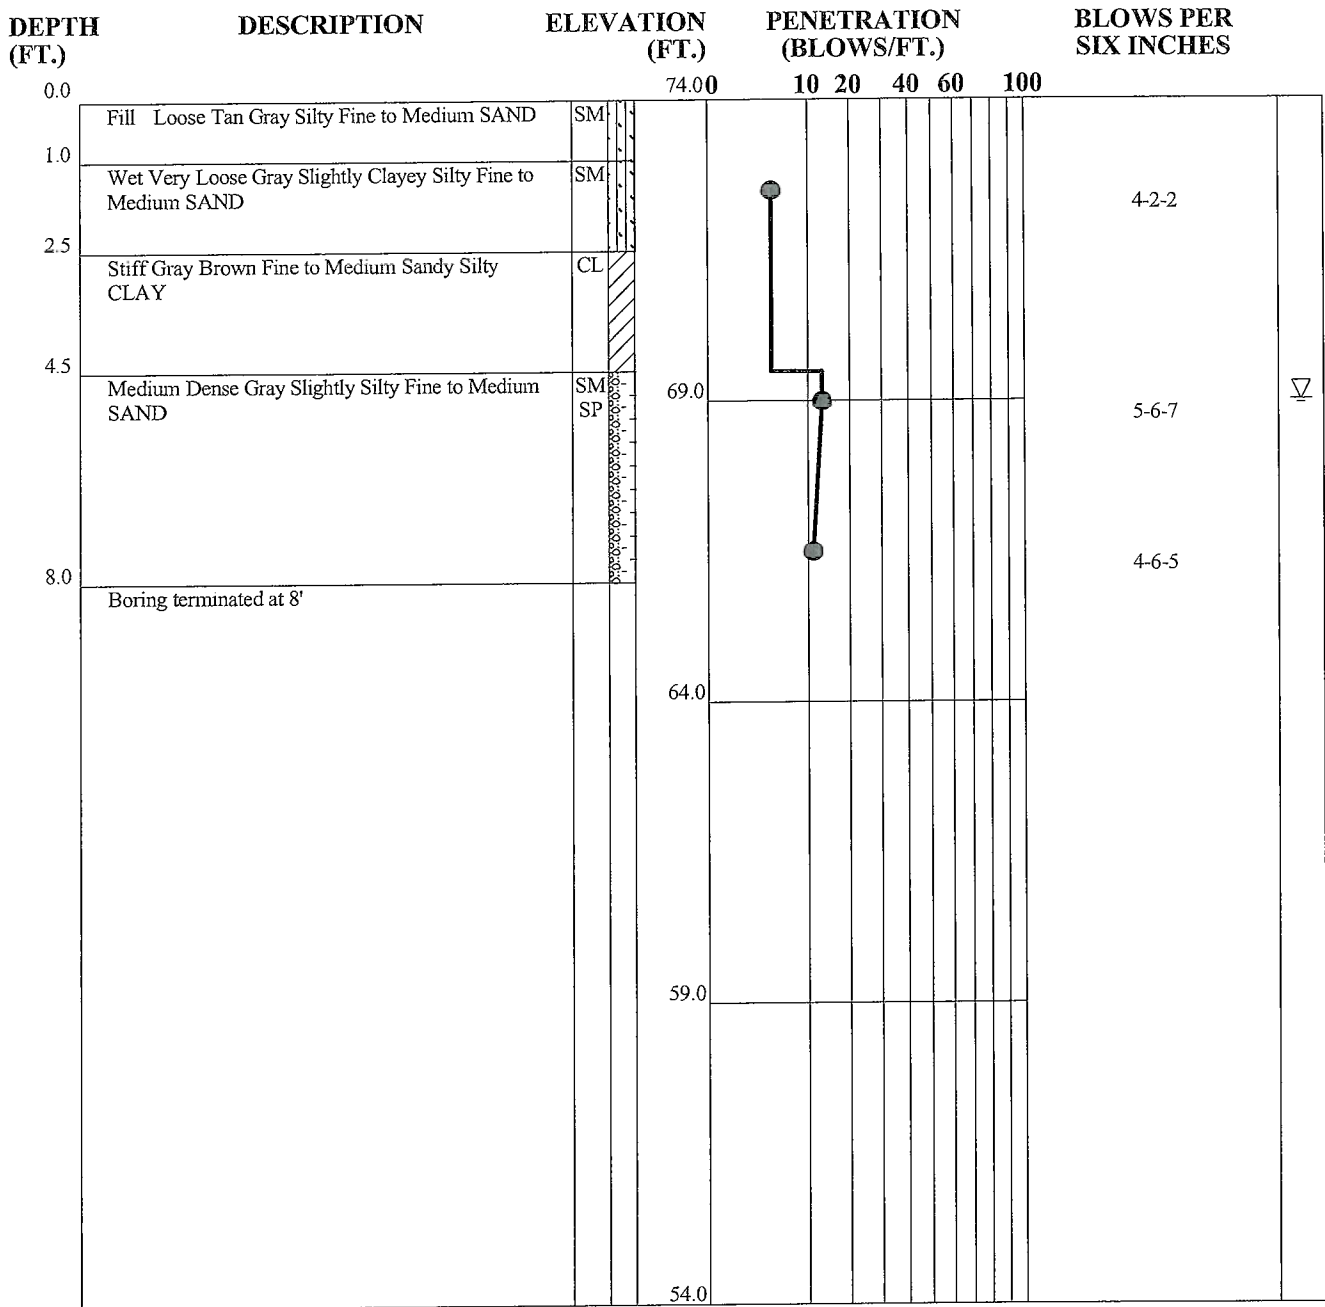
JOB NUMBER 1-10-0029-EA
BORING NUMBER MH-24
DATE 1-25-10

Groundwater encountered at 5' and caved at 6' at time of boring.

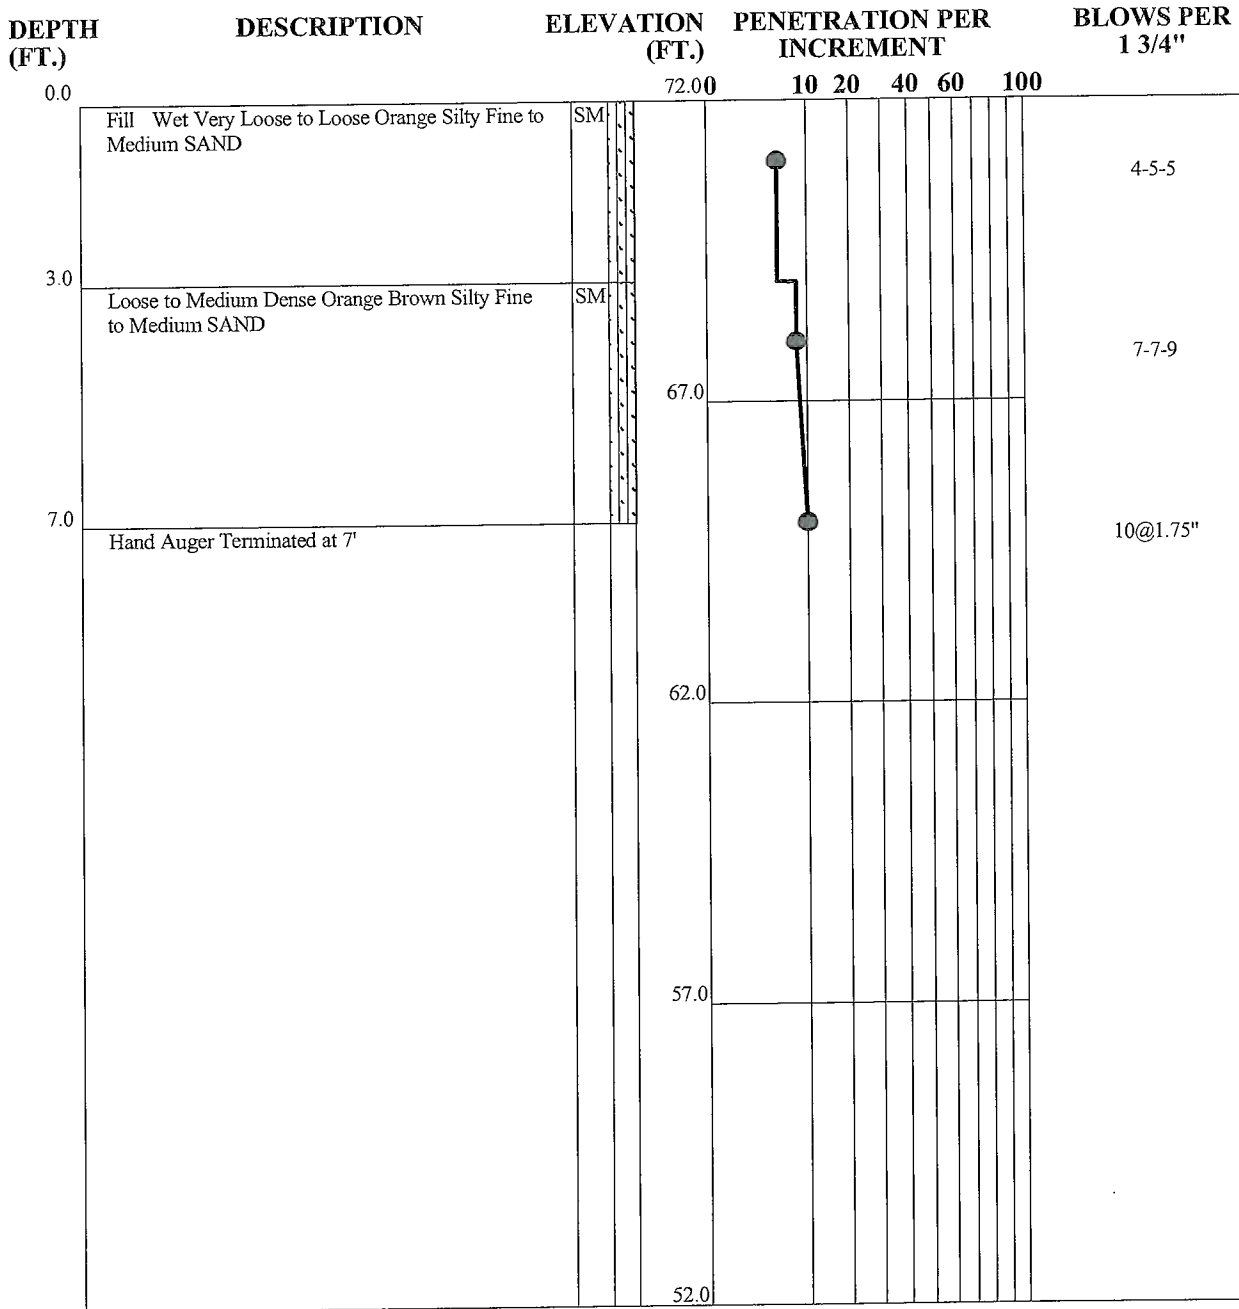
JOB NUMBER 1-10-0029-EA
BORING NUMBER MH-28
DATE 1-25-10

Groundwater encountered at 6' at time of boring.

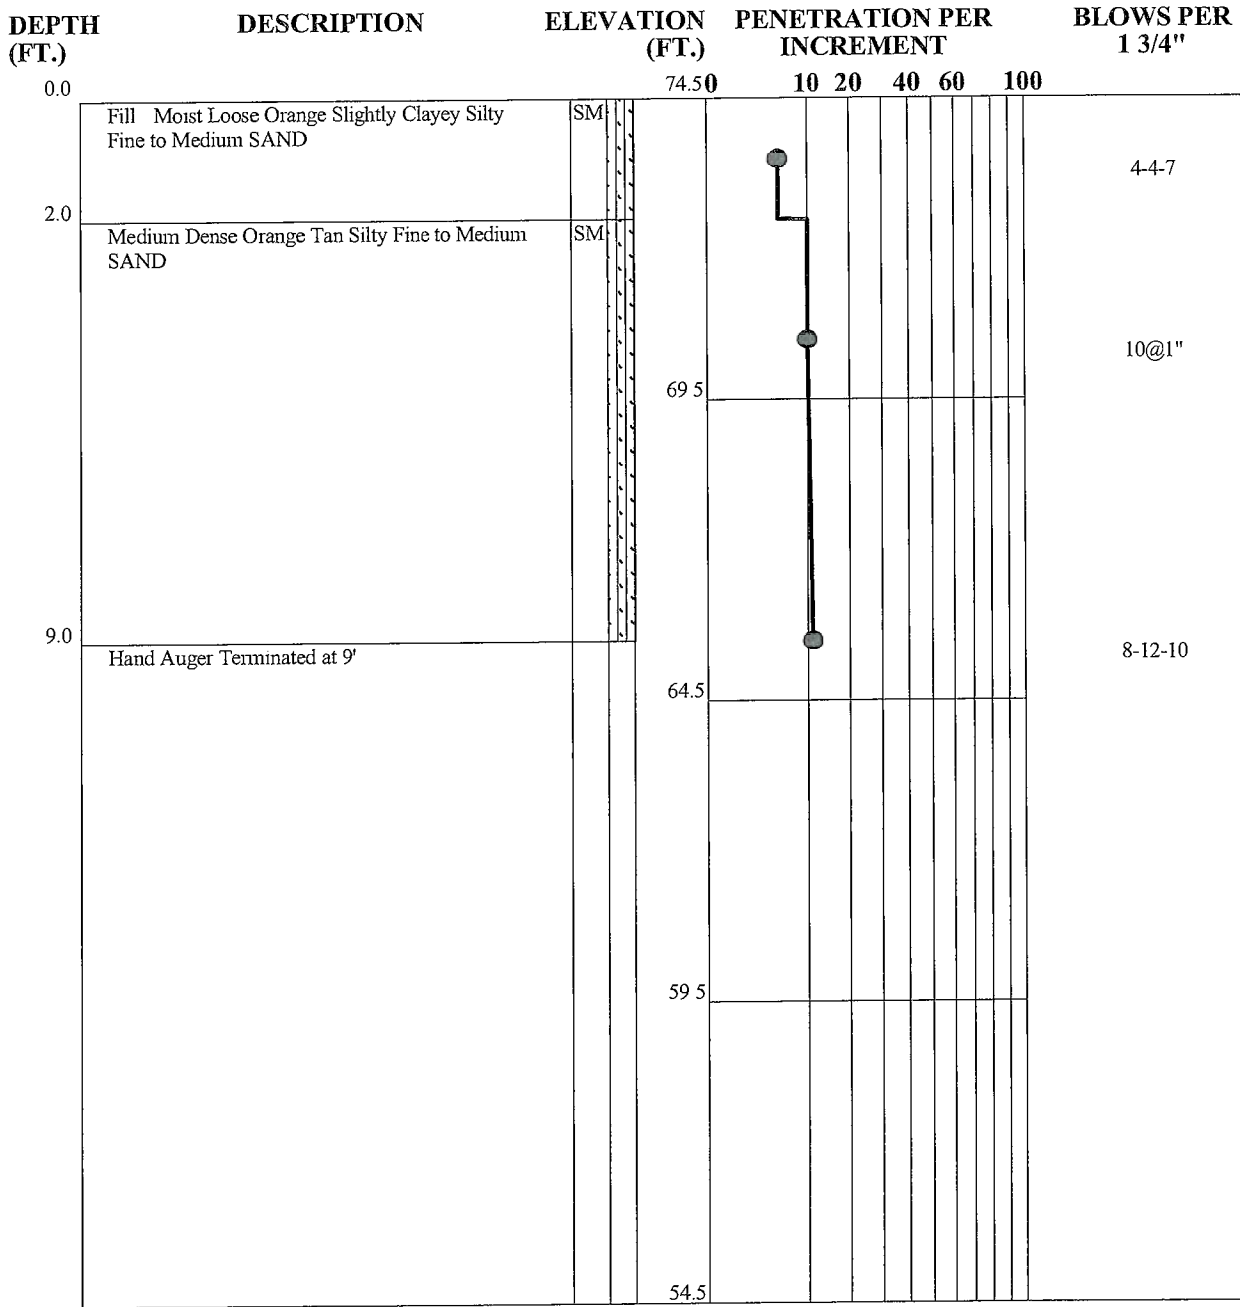
JOB NUMBER 1 10-0029-EA
BORING NUMBER MH-35
DATE 1-25-10

Groundwater encountered at 7' at time of boring.

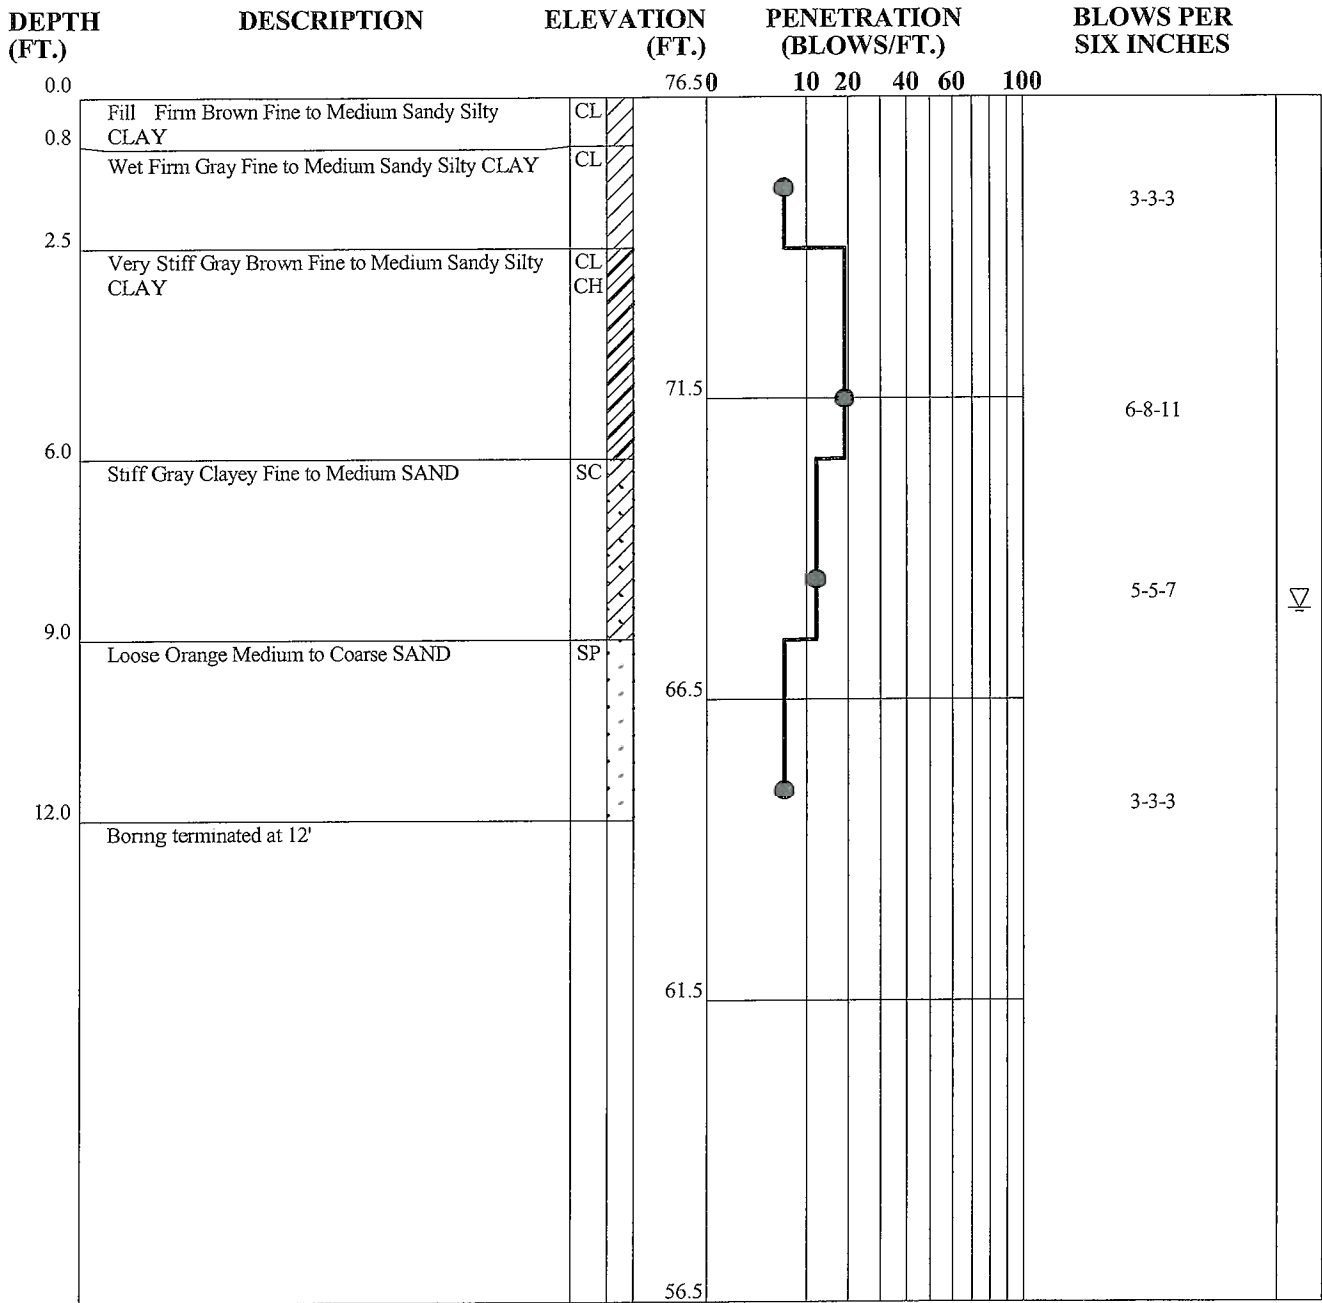
JOB NUMBER 1-10-0029-EA
BORING NUMBER MH-40
DATE 1-25-10

Groundwater encountered at 8.5' and caved at 9' at time of boring.

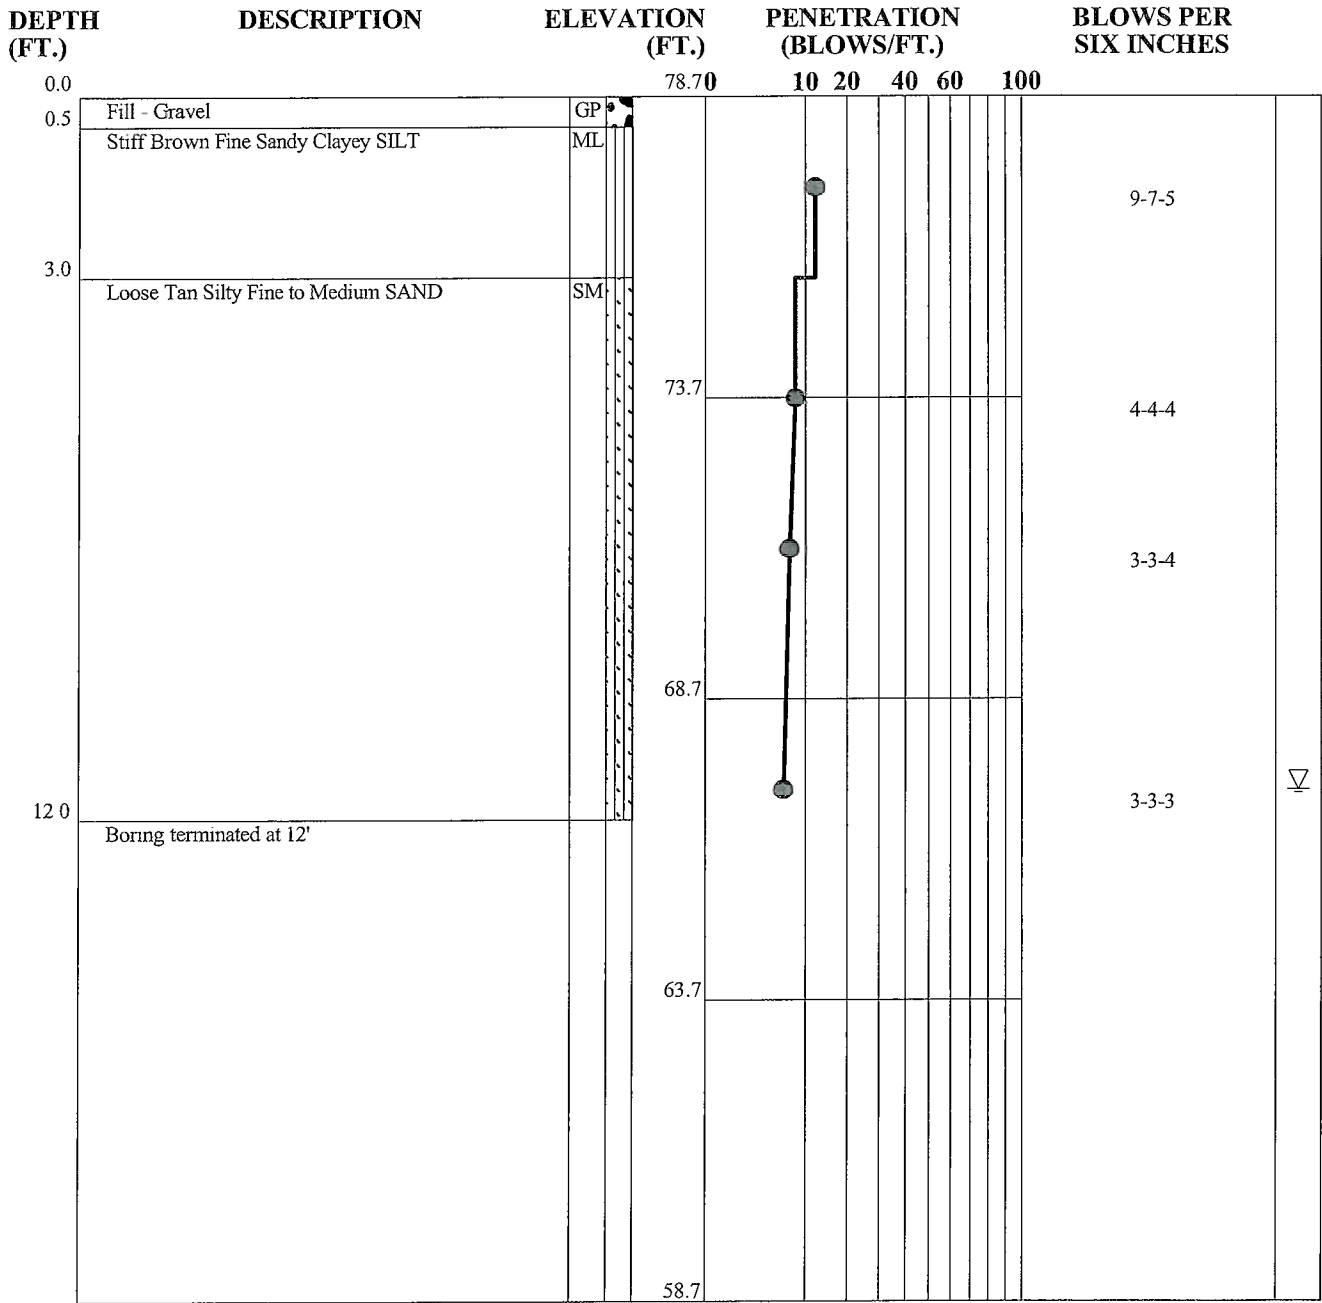
JOB NUMBER 1-10-0029-EA
BORING NUMBER MH-42
DATE 1-25-10

Groundwater encountered at 11 5' and caved at 9' at time of boring.

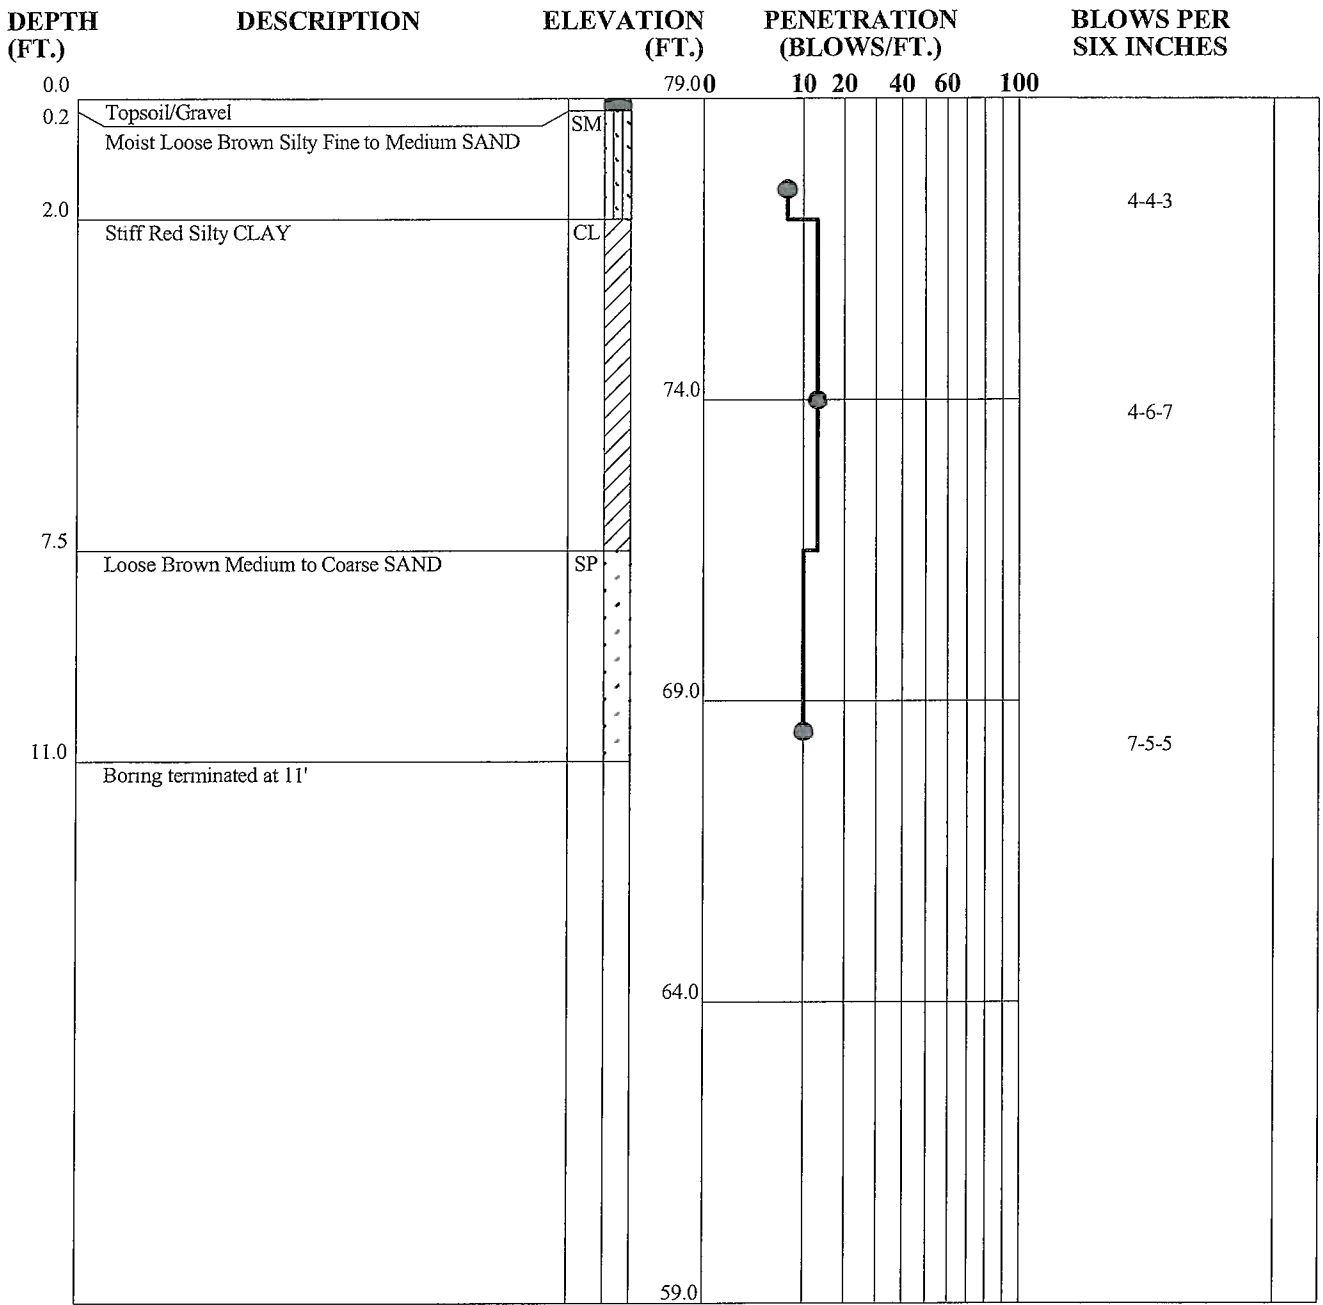
JOB NUMBER 1-10-0029-EA
BORING NUMBER MH-43
DATE 1-25-10

Dry at time of boring.

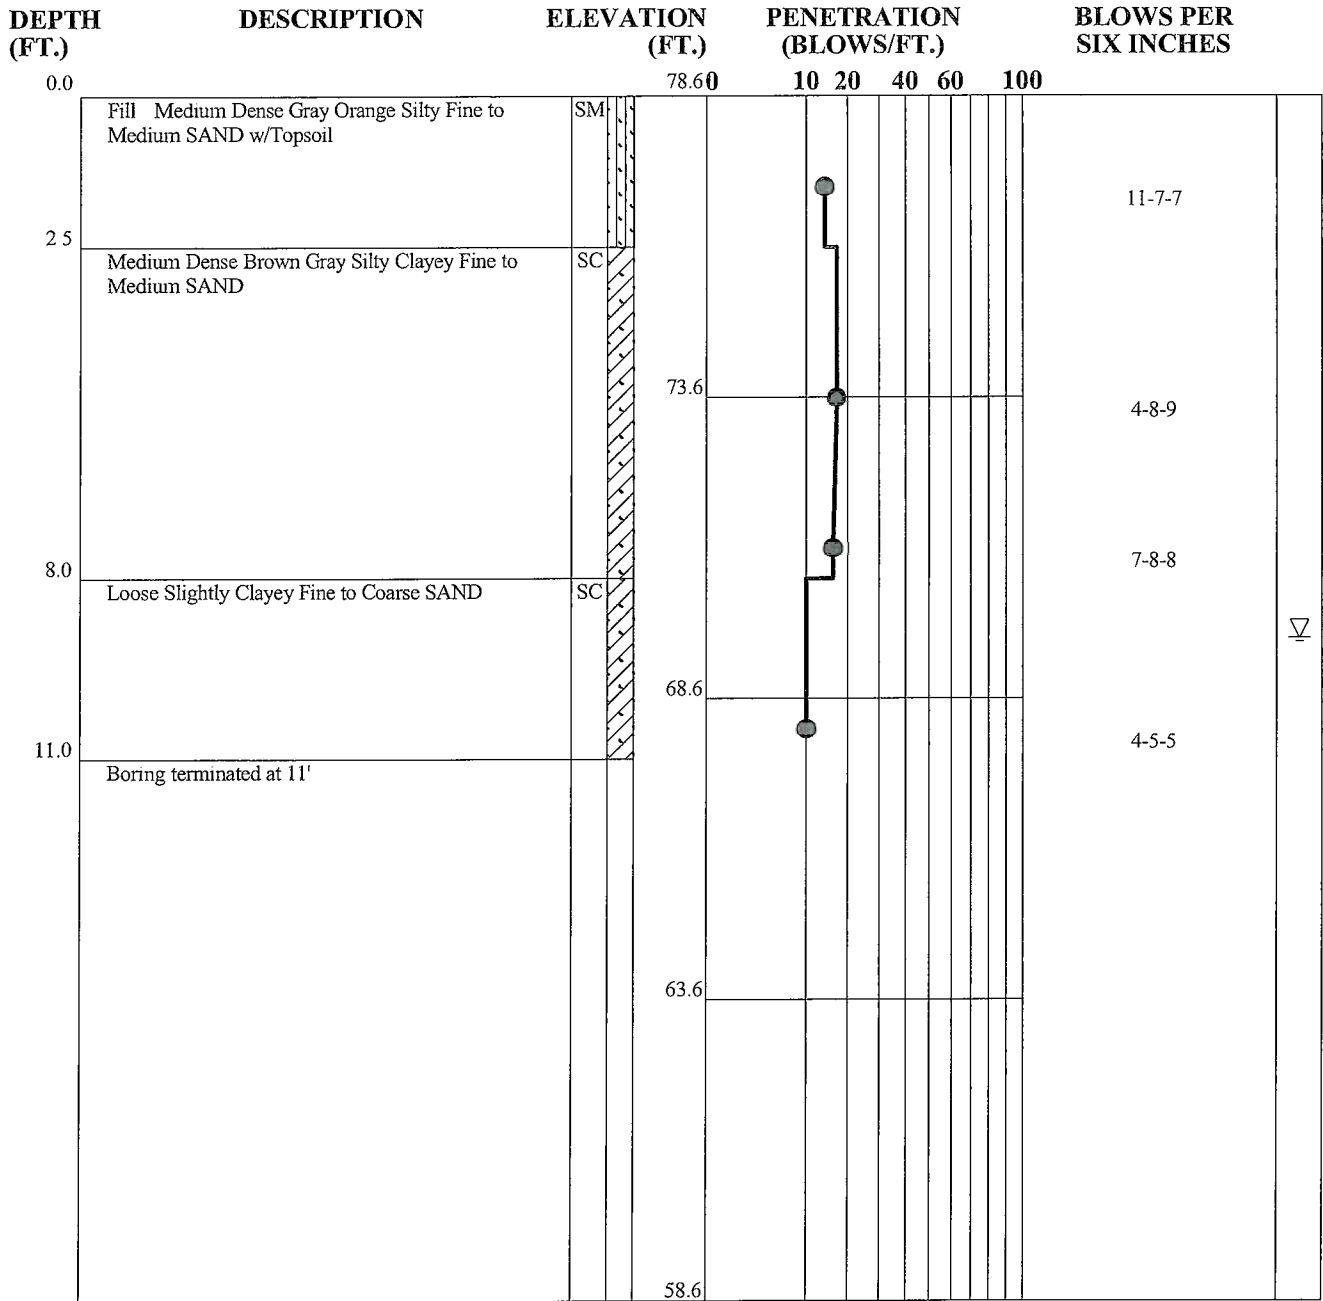
JOB NUMBER 1 10-0029-EA
BORING NUMBER MH-45
DATE 1-25-10

Groundwater encountered at 9' and caved at 7' at time of boring.
